ENERGY-TO-FAILURE TO ASSESS THE QUALITY OF ELECTRO FUSION JOINTS IN PE PIPES

Frans Scholten (frans.scholten@kiwa.nl)

Kiwa Technology, PO Box 137, 7300 AC, Apeldoorn, Netherland.

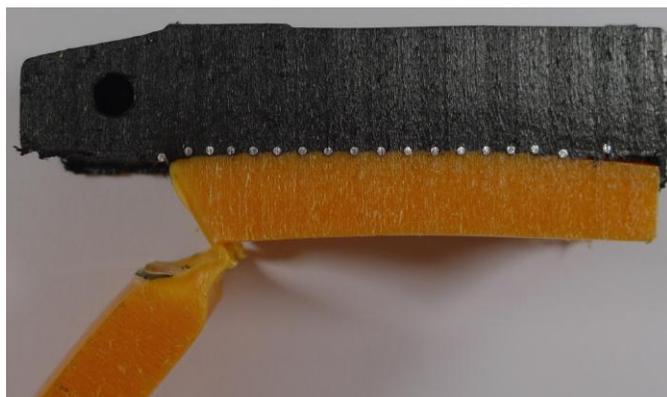
Failure modes of electro fused joints encountered after the Peel test that meet the requirements of EN 1555 are IP (failure in the pipe wall – Figure 1) and BW (ductile failure between the heating wires – Figure 2).

Figure 1. Failure mode IP (in the pipe wall) after the Peel test.

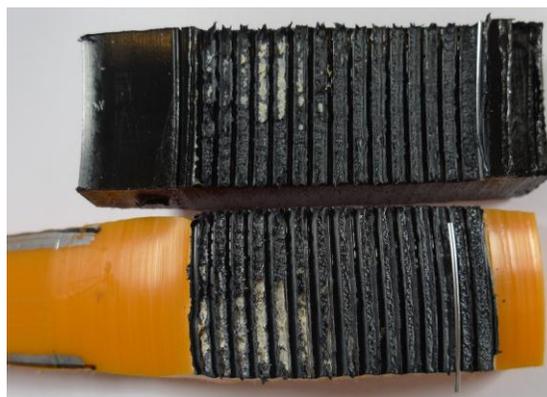
Figure 2. Ductile failure between the heating wires (BW) after the Peel test. Black PE from the fitting still adheres to the orange pipe.

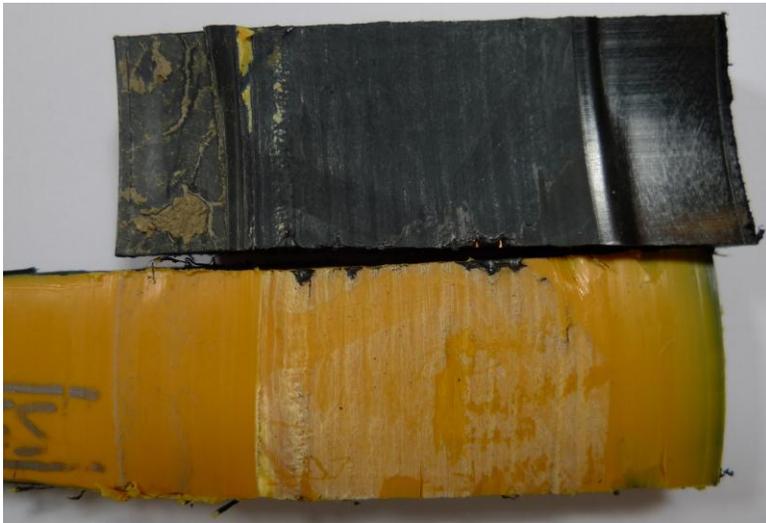
However there is a third failure mode that is not acceptable: condition BF (brittle failure - Figure 3). In this case there is no adhesion of the black fitting material to the external surface of the pipe. Such brittle joints, 39 in total, were investigated using the techniques mentioned in the previous section.

Figure 3. Brittle failure of a test bar after the Peel test. There is no adherence between the black PE material in the fitting and the orange pipe.

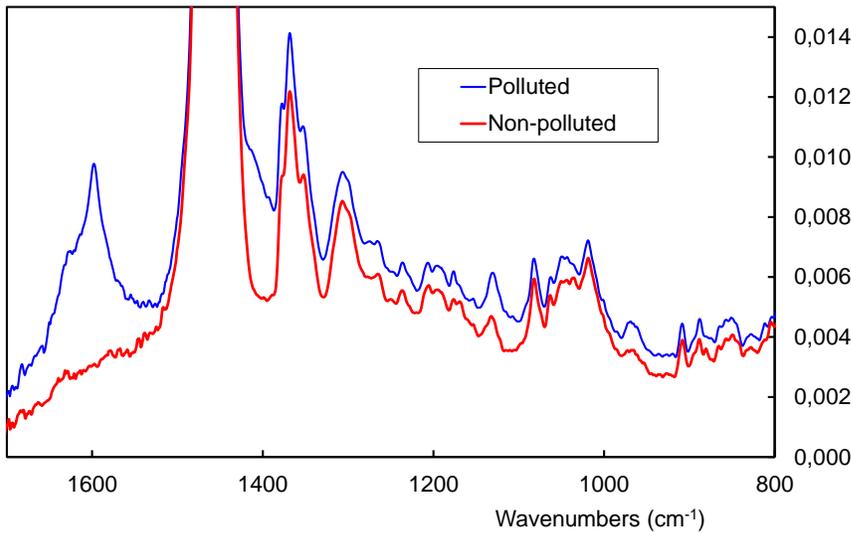
Figure 4 shows infrared spectra measured using IRRS of a brittle joint plane and of an uncontaminated reference sample. Whilst the majority of the peaks are due to Polyethylene and its normal additives, differences are only noted at around 1600 and in the “valley” around 1400 cm^{-1} . Therefore, a difference spectrum is needed and the red spectrum is subtracted from the blue one.

Figure 4. Infrared spectrum of a brittle joint plane (blue) and of a reference sample cut from the middle of the wall of the same pipe (red).

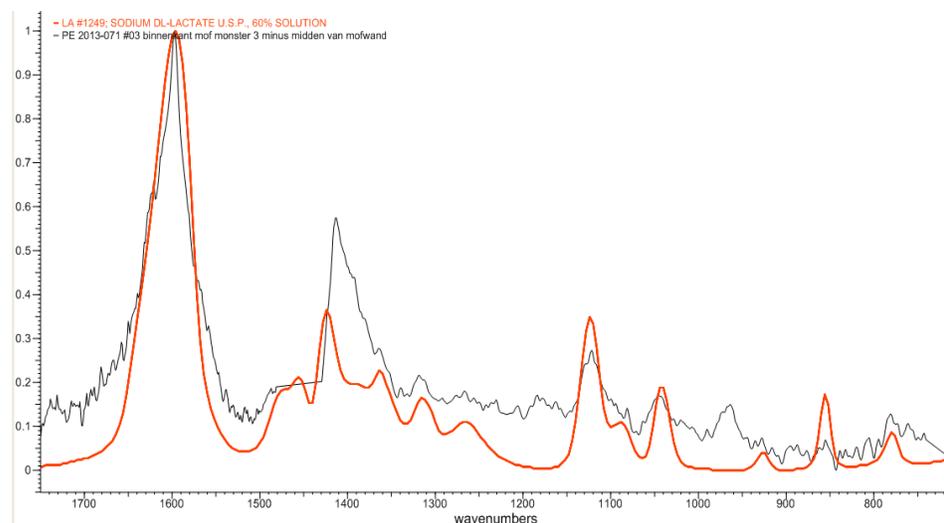
This difference spectrum is shown in Figure 5, together with the best match (although not a perfect one) from the Biorad/Sadtler database (KnowItAll ®, containing 220,000 reference spectra), which is sodium lactate. Sodium chloride and lactic acid are the most prominent components in human sweat. XMA was not performed on this sample.

Figure 5. Black: difference spectrum (blue spectrum minus red spectrum in Figure 4). Between 1480 and 1430 cm^{-1} a poorly compensated PE peak was replaced by a straight line to improve spectral searching. Red: the best match among the reference spectra in KnowItAll[®] is sodium lactate.

In the previous sample which probably contained sodium lactate (Figure 5) and which was only analysed using IRRS, no traces of sodium chloride were found, because this substance has no infrared spectrum.

2. In 13 % of cases the presence of sweat, hand balm and detergent was suspected. It is advised that welders should wear gloves of an appropriate type. In 15 % of cases the identification was inconclusive.

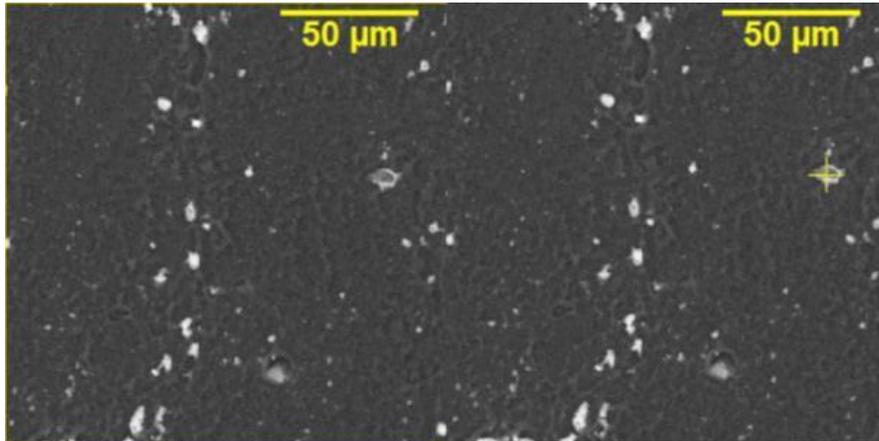
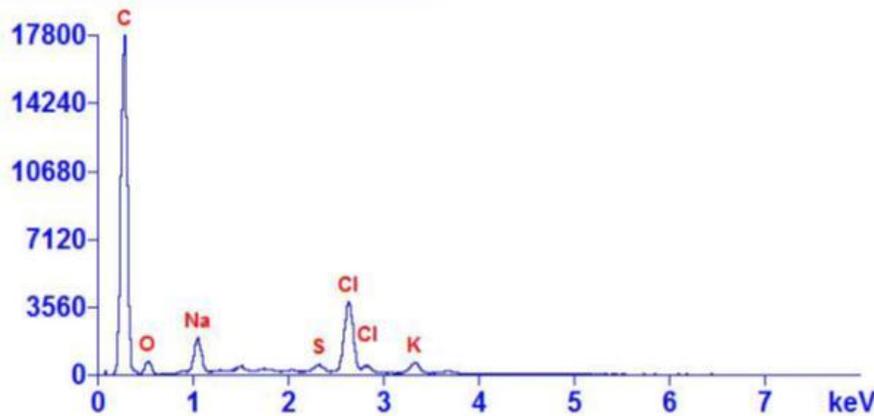
An interesting result is presented in Figure 6. SEM-XMA performed on another brittle joint plane reveals that sodium chloride crystals are arranged in concentric circles. This suggests that a drop of human sweat had splashed onto the pipe surface before fusion had started.

Figure 6.
a. SEM image showing concentric circles of white crystals on a brittle joint plane.

b. The EDX spectrum shows that the crystals consist of sodium chloride.

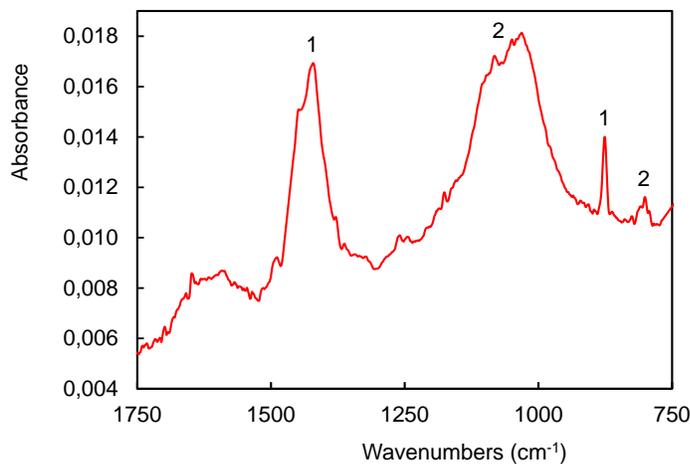
Figure 7. Infrared difference spectrum: spectrum of a joint area that failed in a brittle manner in the Peel test minus the spectrum of uncontaminated PE. By the subtraction the large peaks of PE are compensated. Contamination with calcium carbonate (peaks 1) and silicates (peaks 2) are found.

IRRS performed on in another brittle joint plane reveals the presence of two different contaminants, silicate and calcium carbonate (Figure 7). Both substances show two clear bands and this provides definite identification. Other important contaminants such as silicones were noted in many cases. Detection of silicones and silicates has been described previously [2].

Silicates probably originate from fine particles that had been blown onto the pipe surface by the wind. The silicates are most likely soil particles (sand, clay).

In three cases calcium carbonate was present, which is known [4] to have a negative effect on joint strength as well. This points not to soil, but to fine cement particles. Cement consists of (among others) silicates and calcium oxide ("quick lime", "burnt lime"). The latter particles, when very small, are readily converted to calcium carbonate particles in the presence of carbon dioxide in the air. The presence of calcium carbonate is a tell-tale sign that contamination from a nearby construction site at which dry cement is used has occurred.

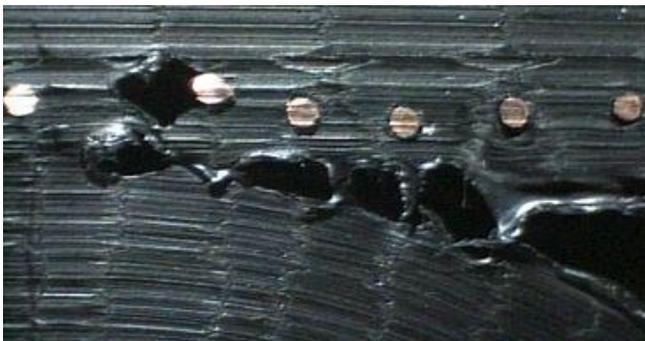
An unwanted phenomenon occurred during electro fusion work performed in the autumn (November) when constructing a new PE100 gas pipeline. A hissing sound was noted during fusion. The joints were cut out and inspected on site. Several unusual voids near the joint plane were observed with the naked eye (Figure 12). In the lab newly-cut samples were taken out of another part of the joint, which revealed more voids. A sample was cut from the wall of such a void. Two more samples were taken from the pipe and the fitting, in both cases far away from the voids. GC/MS analysis was performed only a few hours after cutting. The samples were heated at 210 °C during 15 minutes. Analysis of the vapours (Figure 13) revealed a large peak of a substance evaporated from the first sample that was absent in the latter two samples. MS identification proved that the large peak was due to the presence of isopropanol.

Figure 12. Voids caused by isopropanol evaporated during electro fusion. Voids sizes up to 2 mm.

conditions (6 minutes instead of some seconds for ethanol). Because the short drying time intended for ethanol as prescribed in the jointing protocol was not amended, isopropanol did not have the time to evaporate completely. The high fusion temperature provoked evaporation of the isopropanol, which subsequently gathered to form vapour bubbles in the molten PE. These did not disappear during cooling of the joint. This led to the formation of the voids.

The use of isopropanol as a substitute for ethanol has two negative effects. The lower volatility of the former, as illustrated by the vapour pressure at 20 °C and the higher boiling point (Table 3) leads to a much slower evaporation in comparison to ethanol. Moreover, isopropanol dissolves somewhat better in PE (Table 3), as indicated by its Hildebrand Solubility Parameter [9]. This Solubility Parameter predicts how readily a liquid will dissolve in another substance, in this case PE. The closer the Solubility Parameter of a liquid is to that of PE (16.2 MPa^{1/2}), the more readily the liquid will dissolve in PE. Therefore, the fourth column in Table 3 predicts that isopropanol will dissolve more readily in PE than ethanol does. This effect on its own is also not beneficial to the evaporation rate of isopropanol.

Using isopropanol instead of ethanol for cleaning pipe surfaces may lead to the formation of voids. This occurs when the time allowed for drying is not prolonged. The lower volatility and higher solubility in PE of isopropanol lead to more absorption in the skinned outer pipe surface. At the high fusion temperature bubbles filled with isopropanol vapour are locked in by the molten PE, which subsequently remain as highly undesired voids after cooling. GC-MS proves that isopropanol is still present in the voids and is therefore responsible for their formation. A return to ethanol as cleaning liquid removes such voiding.

4. There are differences in the ability of certain cleaning agents to dissolve silicone spray contamination from PE pipe surfaces. However, different liquids have different evaporation rates and a different solubility in PE. This must be taken into account when changing a cleaning liquid. Such a change inevitably leads to changes in the welding routine, which must be meticulously described in protocols used by welders in the field.
