QUALITY CONTROL OF JOINT INSTALLATION IN PRE-INSULATED PIPE SYSTEMS

E.J.W. van der Stok

Kiwa Technology, Apeldoorn, the Netherlands

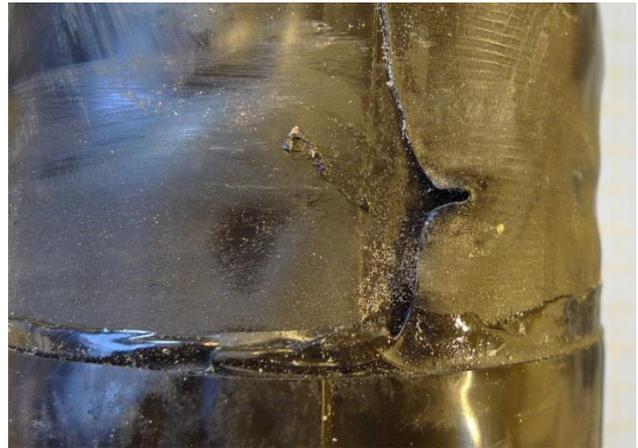
Furthermore, folds or wrinkles in the sleeve or collar of several PEX shrink joints were found (Figure 5 and Figure 6).

Figure 5. Fold in PEX shrink sleeve.

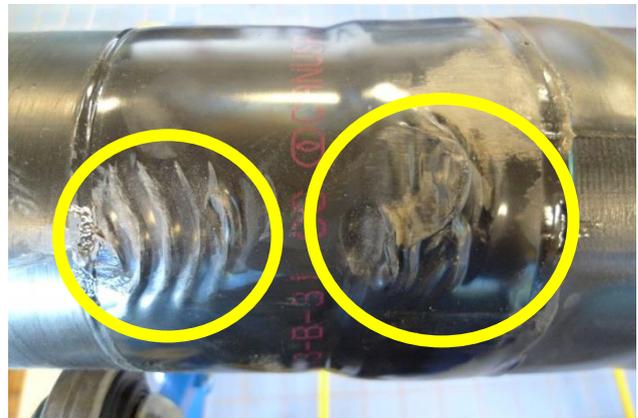
Figure 6. Wrinkles in the collar of a PEX shrink sleeve.

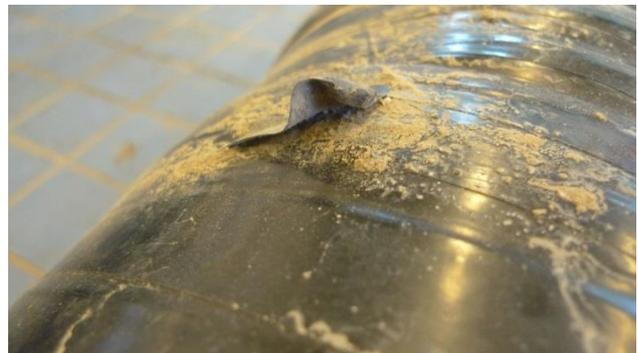
The (small) mistakes were therefore mainly due to sloppiness: folds, air inclusions and tape endings halfway were observed (Figure 7). Tape was also found to have been applied separately over the sleeve ends and the plugs, while it should have been applied in one piece (Figure 8). Although these are not major mistakes, they do introduce unnecessary weak points in the water barrier of the system. The resulting reduction in the leak tightness of the joint is out of proportion to the extra effort required from the pipeline installer in order to apply the tape correctly.

Figure 7. A tape ending halfway across the taped area. This causes a weak spot in the system.

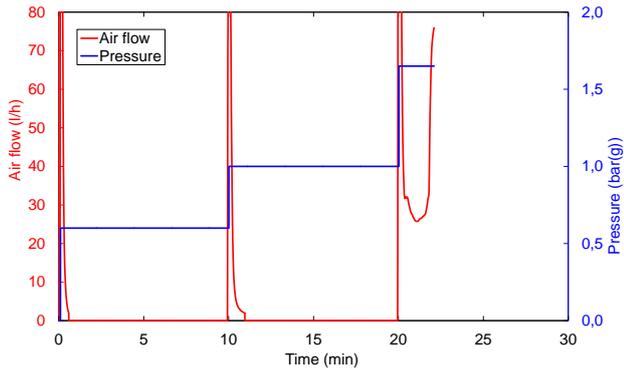
Figure 9. Air flow (lower trace, red) and pressure (upper trace with steps, blue) during a pressure test with air until failure of the PE shrink joint. Below 1 bar(g) the air flow is 0 l/h after an initial peak as the pressure increases. At 1.5 bar(g) the air flow increases considerably, indicating a leak.

Five of the 20 PE shrink joints failed during the leak tightness test (Figure 9 and Figure 10). None of the other joint types failed.

The five defective PE shrink joints all failed at the plugs. In one of the five cases, the butyl rubber and Densolen tape were strong enough to withstand the pressure; the tape thus blew up like a balloon. In the other four cases the tape did not have enough adhesive strength; this created a leak path. The poor adhesion was confirmed during destructive inspection.

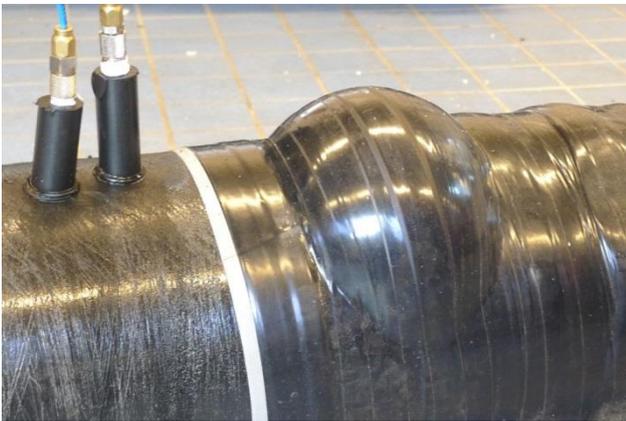
Figure 10. Failed joint after being pressurised up to 1.5 bar(g).

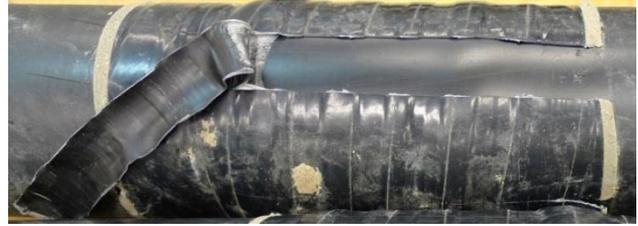
In more than 50 % of the PE shrink joints, one or more tape strips could be peeled away from the casing and/or PE shrink sleeve (compare Figure 11 with Figure 12). It was often found that the pipe ends and PE sleeve were not properly abraded. Improper abrading can therefore result in a low bonding strength of the tape, which decreases the quality of this water barrier and thus increases the possibility of water entering the joint.

Figure 11. A poorly abraded joint, resulting in a low tape bonding strength. The tapes were easily peeled away from the PE casing and shrink sleeve manually. The quality of this water barrier is therefore low.

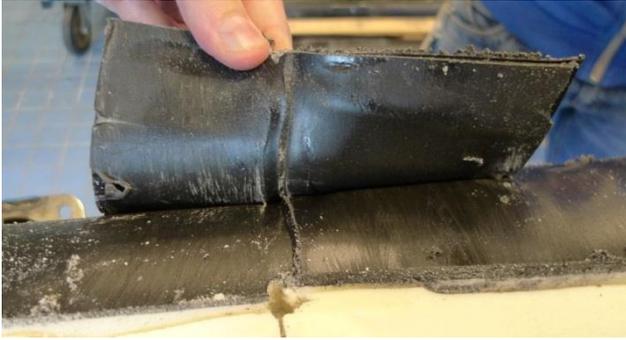
Only about 15 % of the collars in the PEX shrink joints could be peeled away from the casing and/or PEX shrink sleeve manually (Figure 13). In slightly more cases (about 20 %) the PEX shrink sleeve could be peeled away from the casing manually (compare Figure 14 with Figure 16). Insufficient heating, insufficient abrasion and/or contamination, e.g. by sand, of the joined surface are expected to be the principle causes of the poor adhesion. In the other cases the PEX sleeve and shrink film all had strong bonds with the PE casing. In each of these cases considerable force was needed to separate the various components at room temperature.

Figure 13. The collar of this PEX shrink joint could easily be detached manually from the casing and the PEX shrink sleeve.

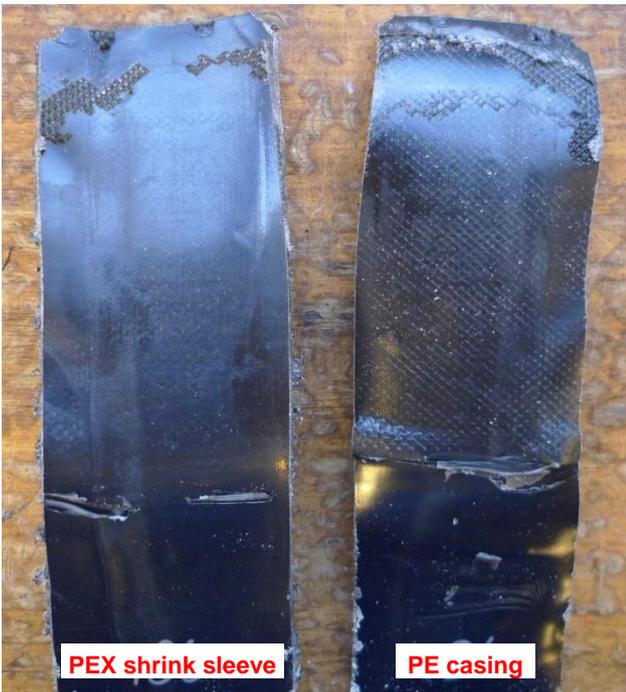
Figure 14. There is no bonding strength between the PEX shrink sleeve and PE casing, probably due to insufficient heating.

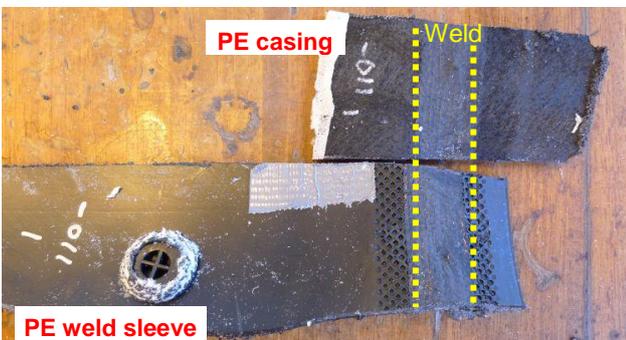
Surprisingly, over 60 % of the welded joints could also be manually peeled away from the PE casing (compare Figure 15 with Figure 17). In a welded joint, the PE of the casing and sleeve are melted together to form a very strong bond.

Being able to manually peel the sleeve away from the casing is a clear indication that the casing and sleeve have not fused together properly. Welded joints are used in the most severe conditions and for the most important district heating systems. Since this type of joint only has two water barriers (in some cases, even the collars are omitted), a good weld is essential in order to guarantee the quality of the entire joint.

Figure 15. The PE weld sleeve and the PE casing are not properly fused. The PE weld sleeve could therefore easily be manually peeled away from the PE casing.

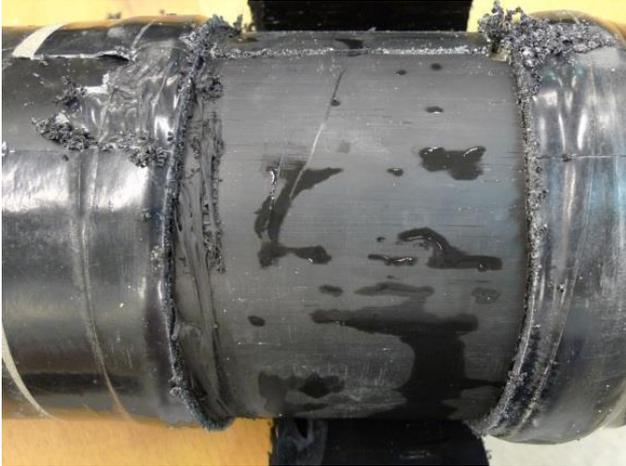
In two PE shrink joints, water was found trapped beneath the PE shrink sleeve (see Figure 18). This could have been caused either by condensation or by rainfall. Regardless of the cause, the pipe and other components had not been properly dried before joining, despite this being specified in the installation instructions. Since water had already passed the water barriers, the risk of joint degradation was increased.

Figure 18. PE shrink sleeve removed to show water trapped in the joint.

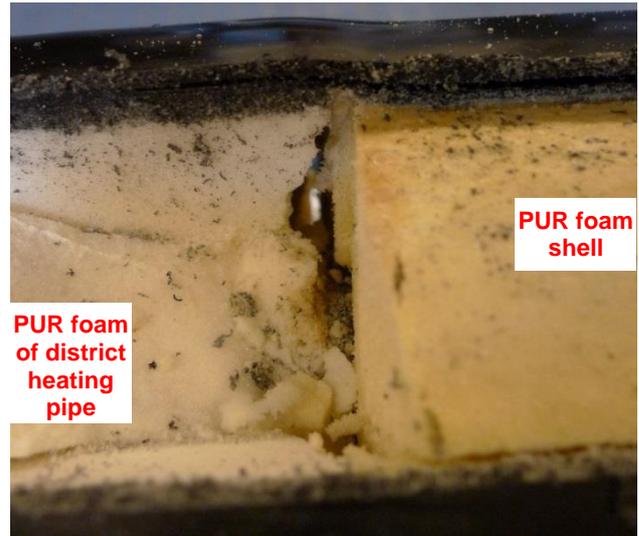
Figure 20. PUR foam is cut very irregularly, so that the PUR foam shell does not fit tightly, which leads to large gaps.

In about 10 % of the joints the PUR foam shells were not placed tightly enough against the PUR foam of the district heating pipe (3 in Figure 1), resulting in large gaps (Figure 20). Such gaps are undesirable as they lead to:

1. Extra heat losses.
2. Heat build-up in the mastic used in the PEX shrink joints, leading to possible movement of the collars and shrink sleeves.
3. Migration of any water that may have entered the joint towards the steel service pipe. The water will heat up and become very hostile to the PUR foam. Hot water can quickly degrade and hydrolyse the PUR foam, thus decreasing the thermal insulation. This will cause the water to heat up still further, etc. If the new joint is subsequently foamed, then this process will occur much less quickly, since the water cannot easily reach the hot service pipe. This in turn means that it will take longer to heat up and attack the PUR foam.

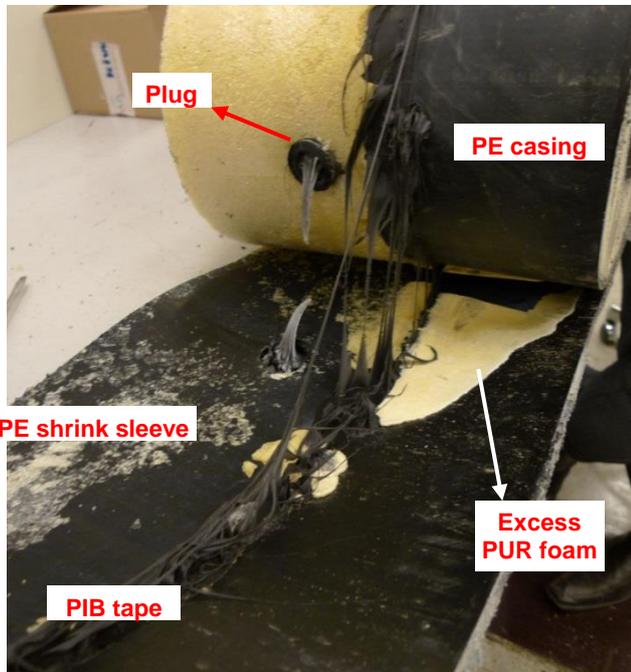
Figure 19. PUR foam has flowed beyond the PIB tape barrier, creating a failure in the first water barrier.

Inspection of the PIB tape in PE shrink joints revealed that in various cases, PUR foam had flowed beyond the PIB tape barrier (Figure 19). After joining the steel pipes, the annular space between the service pipe and the PE sleeve is filled with foam. It appeared that the foam had been able to flow beyond the PIB tape. The PIB tape, which is the first water barrier, was in the process destroyed. This is therefore a very undesirable situation.

The noted defect is not a result of the pressure test, since the cured PUR foam is a very rigid material and should not therefore be able to flow beyond the PIB tape.
