Non-Destructive Ultrasonic Inspection to Detect Flaws in Plastic Pipe Walls and Joints – Correlation with Lab Testing

Frans L. Scholten, (frans.scholten@kiwa.nl), Kiwa Gastec Technology,
PO Box 137, 7300 AC Apeldoorn, the Netherlands,
Hyeon Jae Shin, (hjshin@indesystem.com), Inde Systems,
300 Chonchon-dong Suwon, 440-746, South Korea.

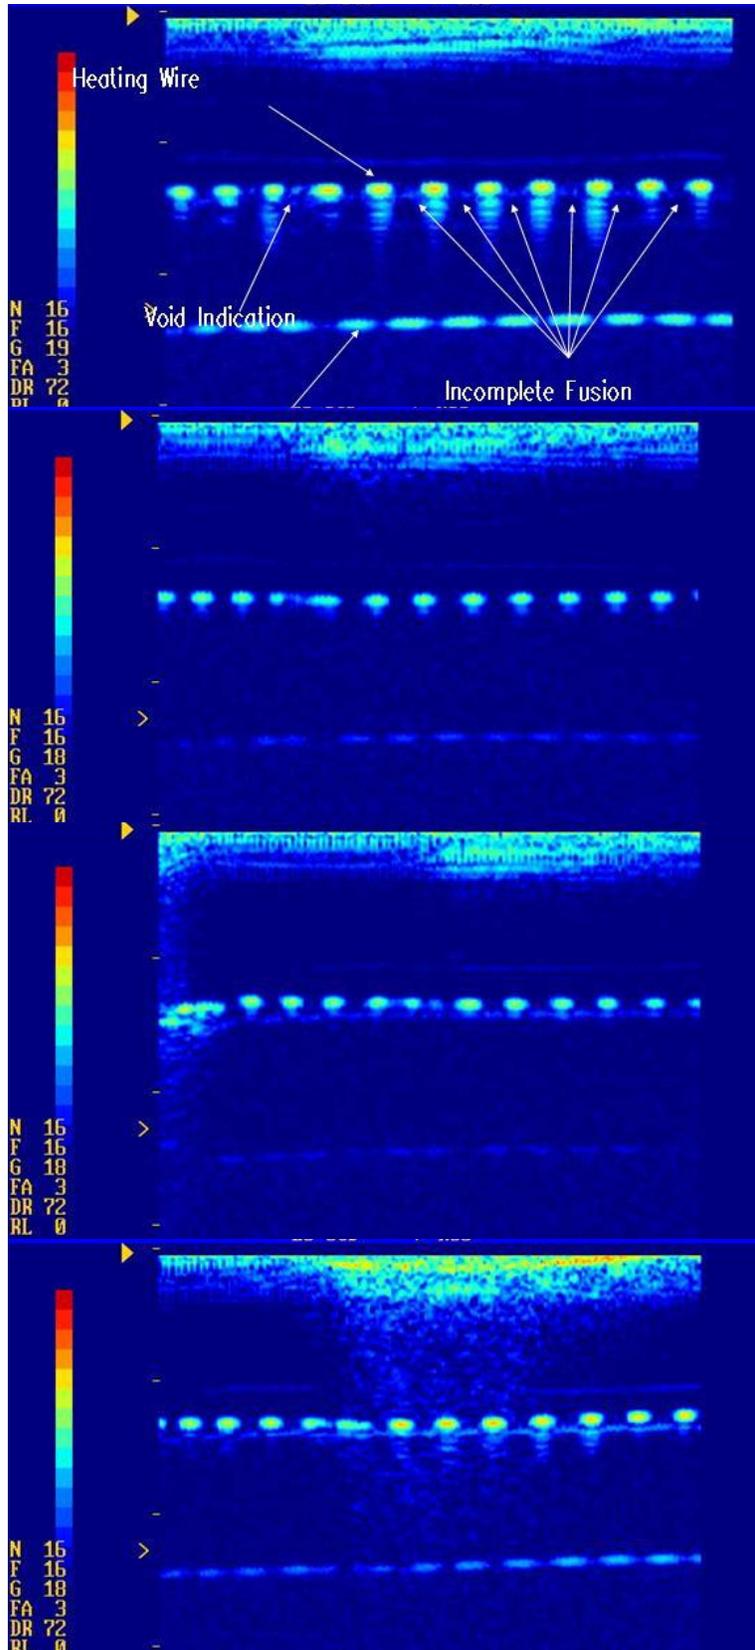
The joint in pipe B (PE100 pipe) is best. The joints in the other 3 pipes, all PEX pipes, show many locations with incomplete fusion. The back wall echo of the incompletely fused joint interfaces is worst for the joints in pipes A and D.

The observations indicate that joints A and D have a lower quality than joints B and C.

Figure 1. Ultrasonic inspection image of electro-fused joint in pipe A. Arrow in lower left corner indicates back wall echo. There are many signs of incomplete fusion.

Figure 2. Joint in pipe B, showing acceptable joint quality.

Figure 3. Joint in pipe C with some locations of incomplete fusion. Other locations in this joint show more incomplete fusion than this. On the left is an indication of a cold zone.

Figure 4. Joint in pipe D.

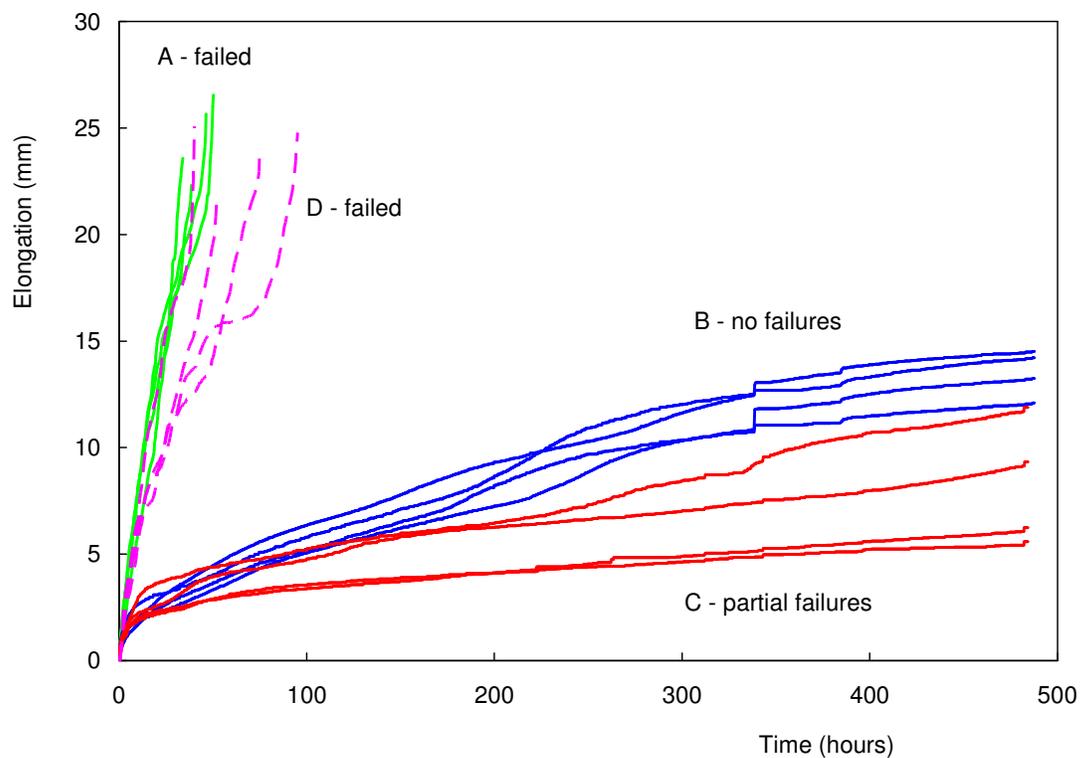
Figure 5 shows the results of Slow Peel tests performed on the same joints, on 4 test bars of each joint type. Figure 6 to Figure 9 show some of the test bars after 500 hours of testing in the Slow Peel test. The results are quite different. Joints A and D show relatively short times-to-failure. The joint in pipe C is much better and shows only partial peel-off, while joint B is best. It only shows failure in the pipe and not in the joint area.

Figure 5. Elongation of 4 test bars taken from each of the 4 types of electro-fused joints during Slow Peel testing at 95 °C.

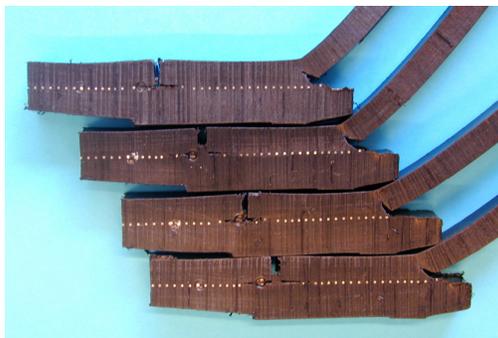
Figure 6. Test bars from a joint in a PE100 pipe "B" after Slow Peel testing.

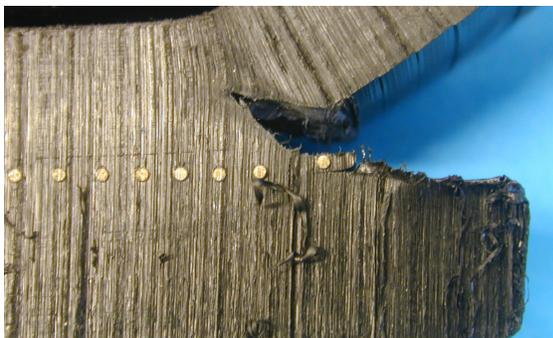
Figure 7. Enlargement of Figure 6.

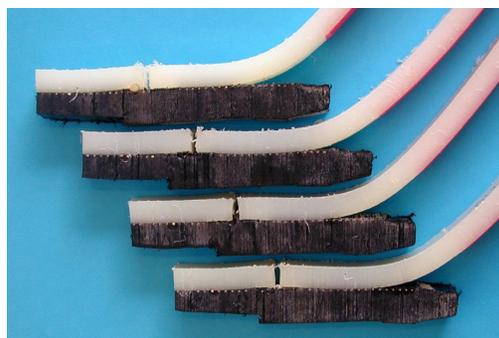
Figure 8. Test bars from a joint in PEX pipe "C" with partial joint failure after Slow Peel testing.

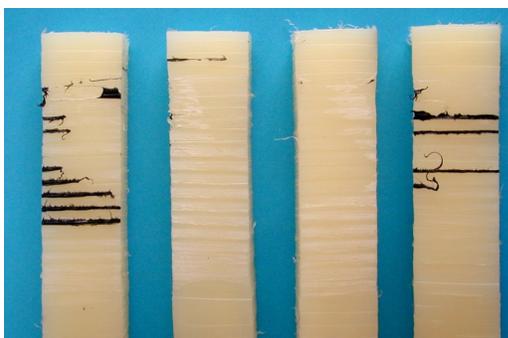
Figure 9. Test bars from an electro-fused joint in PEX pipe "D" after complete peel-off in the Slow Peel test.

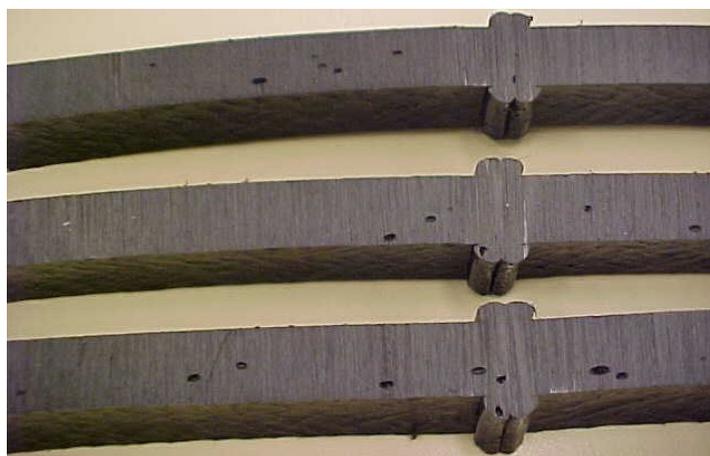
Test bars taken from the wall of an ill-produced communication cable jacket pipe that had failed during trench-less installation were investigated. Figure 10 shows the voids in the pipe wall. All six test bars taken from non-fused pipe showed an Elongation at Break below 295 % (lowest value 82%). Six test bars from a butt-fused joint in this pipe had a very low average Elongation at Break of only 12%.

Figure 10. Test bars from a PE pipe with internal voids and a butt fused joint.

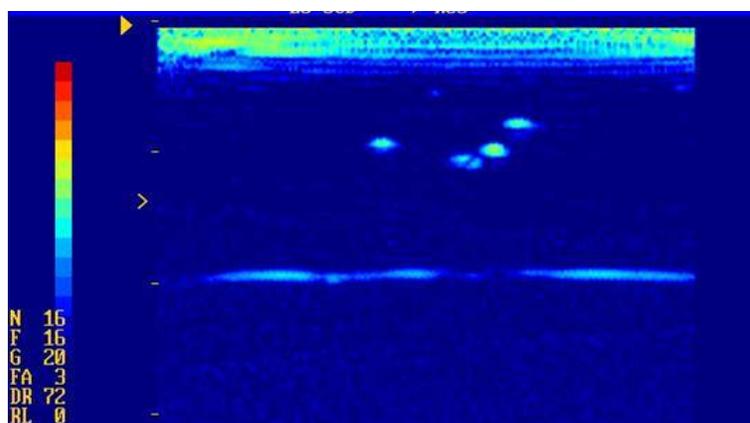
Figure 11 shows an example of the ultrasonic image of such a test bar. At three different locations, a total number of 141, 145 and 108 individual voids could be counted respectively.

Figure 11. Ultrasonic image of the pipe in Figure 10 showing internal voids.

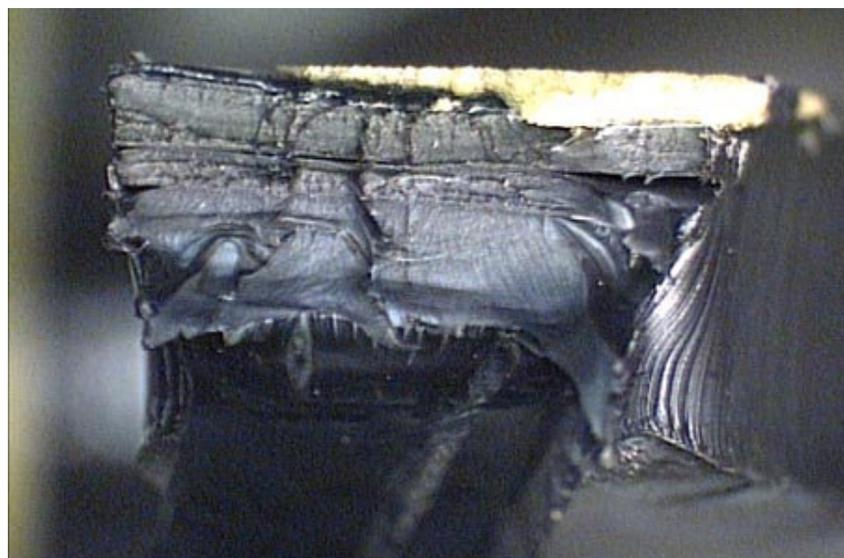
Several years ago, a district heating pipe had become defective after about 8 years of service. It appeared that the jacket pipe had failed. Constant Load tests on the jacket pipe proved that the geometric mean of the time-to-failure in the Constant Load test according to EN 253 was only 145 hours, while 1500 hours was required.

It appeared that the jacket pipe had been produced from thin pre-heated foils that had been wound on top of each other, until the required wall thickness was reached. Due to incomplete fusion between the consecutive foil layers during production, holes had formed between the foils (Figure 12).

Figure 12. Wall of a PE jacket pipe from a district heating system after failure, showing the different layers of foils and the voids in between. Top layer: yellow Polyurethane heat-insulation foam.

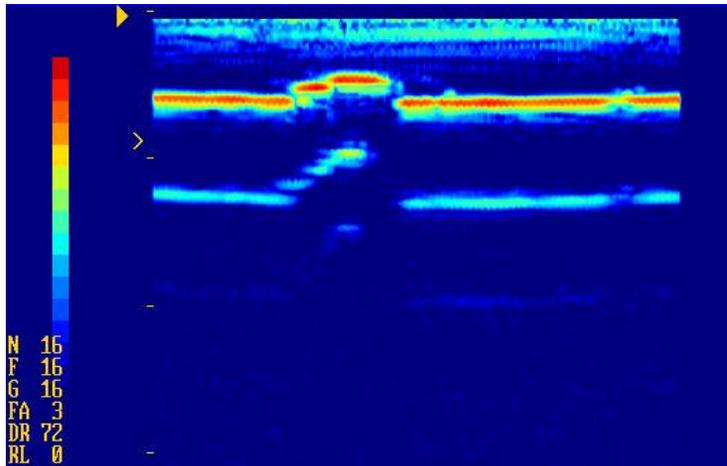
Figure 13 shows that ultrasonic imaging makes the voids between the adjacent foil layers clearly visible. Non-destructive ultrasonic inspection after production could have prevented delivery of such a jacket pipe.

Figure 13. Ultrasonic image through the wall of the PE jacket pipe in the previous Figure. Holes in axial direction between the adjacent foil layers in the pipe wall are clearly detected.

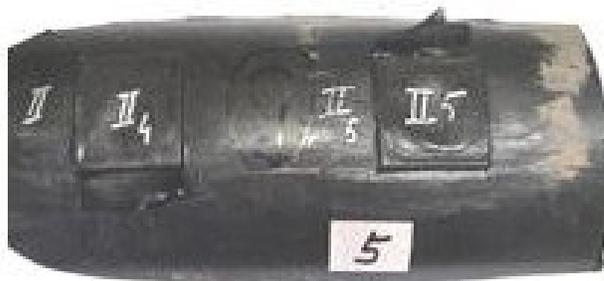
Figure 14. Part of a shrink sleeve around a joint in a 110mm district heating pipeline, containing 2 plugs welded in two holes in the sleeve.

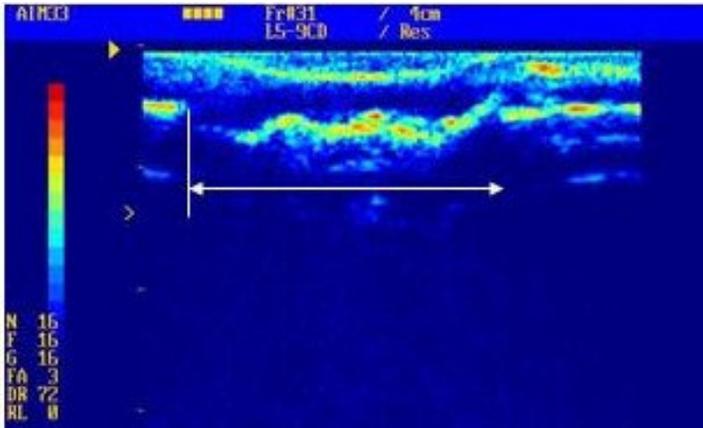
Figure 15. Ultrasonic image of the region around a fused plug, with diameter of about 20 mm (horizontal arrow). Tapered side on the left well-fused, tapered side on the right not well fused.

Some of similar fused plugs in an older district heating system appeared to be leaking due to poor joint quality. This was caused by contamination and poor workmanship.

Figure 15 shows an ultrasonic image of the area around a fused plug. On the right-hand side of the tapered plug a poorly jointed region is visible, which may provide a leak path for ground water. Such leakage may initiate the disastrous chain of events described above.
