# What Solar Module Test Failures Reveal in 2026

## Key Takeaways from Kiwa PVEL's PV Module Reliability Scorecard

Todd Karin, VP of Technology.

9/14/2026. EUPVSEC 2026. Rotterdam, NL

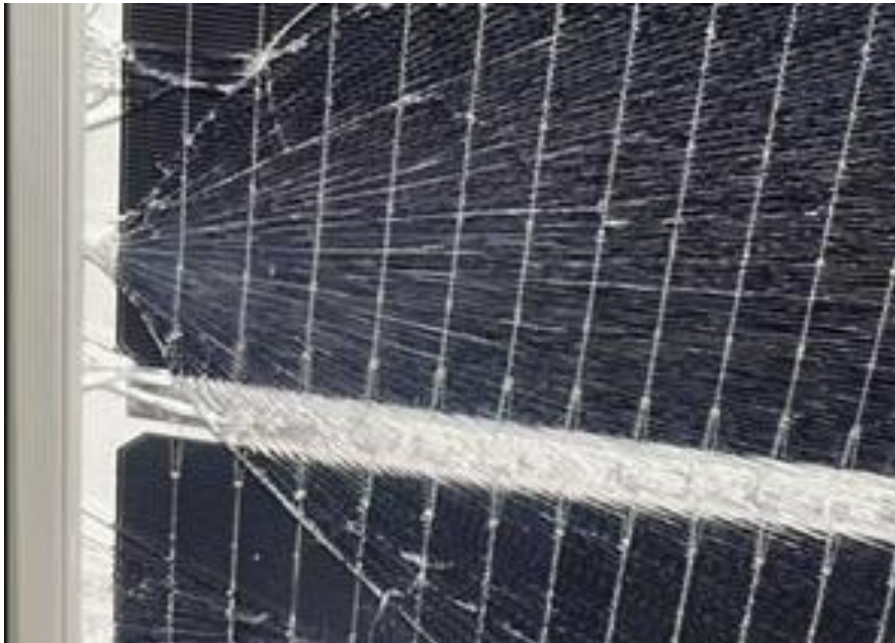
62% of broken modules in MSS showed evidence of pinched glass via front glass breakage.  
Example:

Module-1 broke during testing, showing a clear point of breakage due to edge pinch.

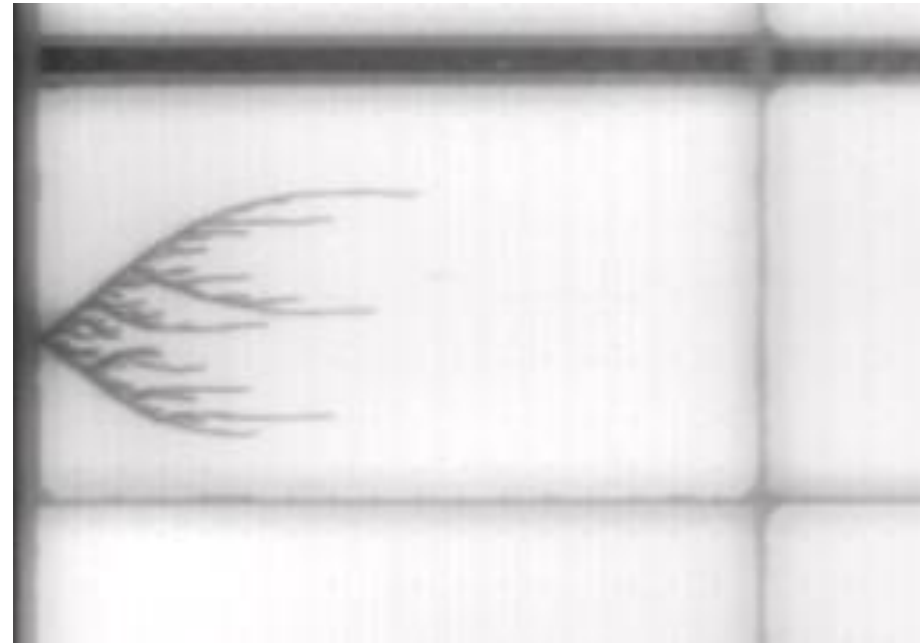
Module-2 did not break, but edge pinching on one cell can be seen in the EL image.

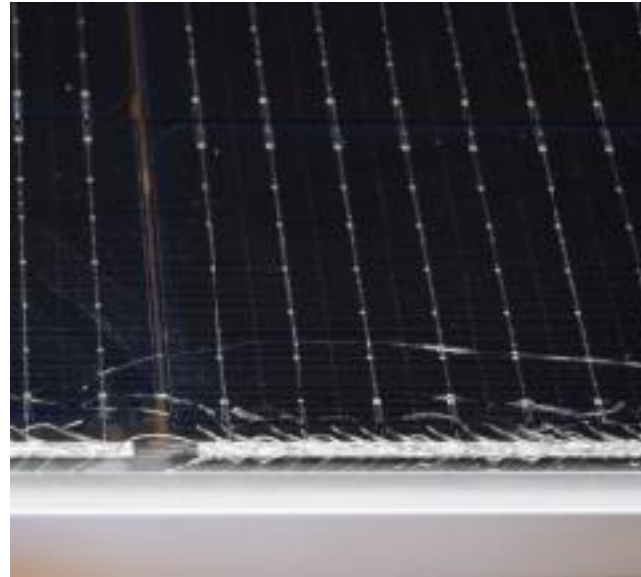
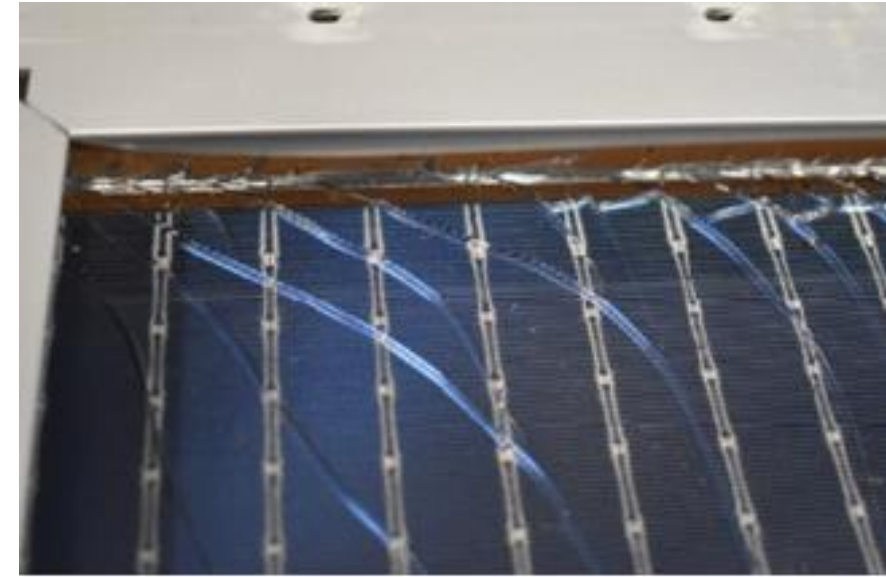
Kiwa PVEL recently observed six of 20 modules from one BOM with broken glass after weeks of outdoor exposure.

The cracks along the busbars indicate a lack of encapsulant along the laminate edges, leading to edge-pinch induced stress concentration points between the metal busbar and the glass surface.

Glass cracking stemming from the module busbars in glass//glass modules can be prevented with thicker encapsulant and/or changes to lamination recipe.

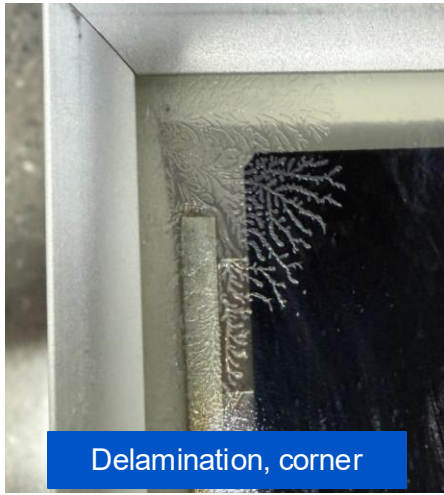
Delamination, corner

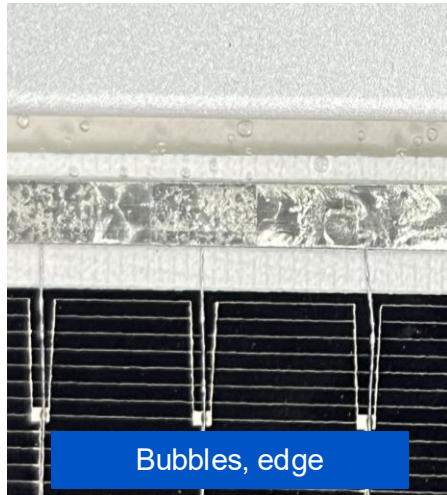
Bubbles, edge

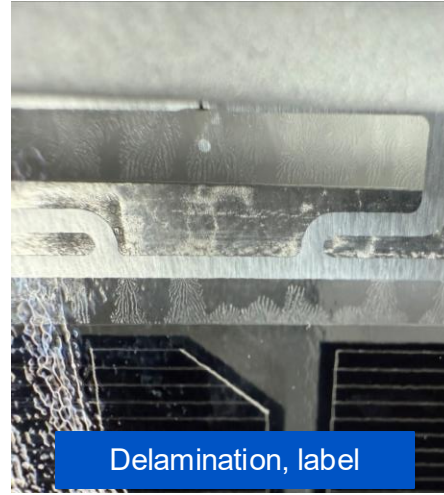
Delamination, label

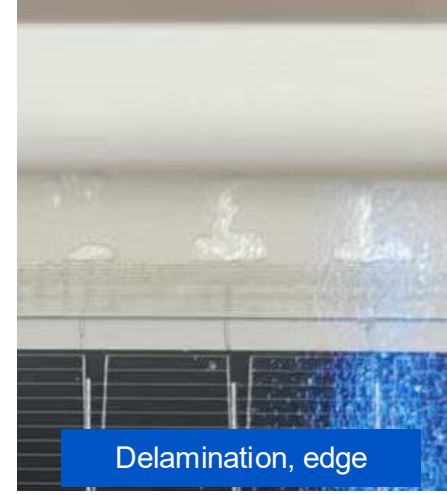
Delamination, edge

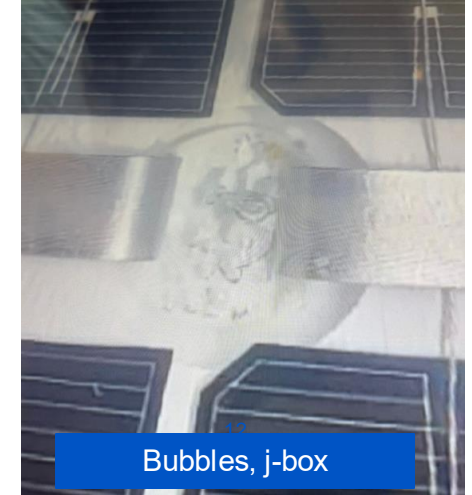
Bubbles, j-box

Per IEC61730, bubbles are assumed to be conductive. Considered a Major Defect when creepage distance is below IEC 61730-1 requirements.

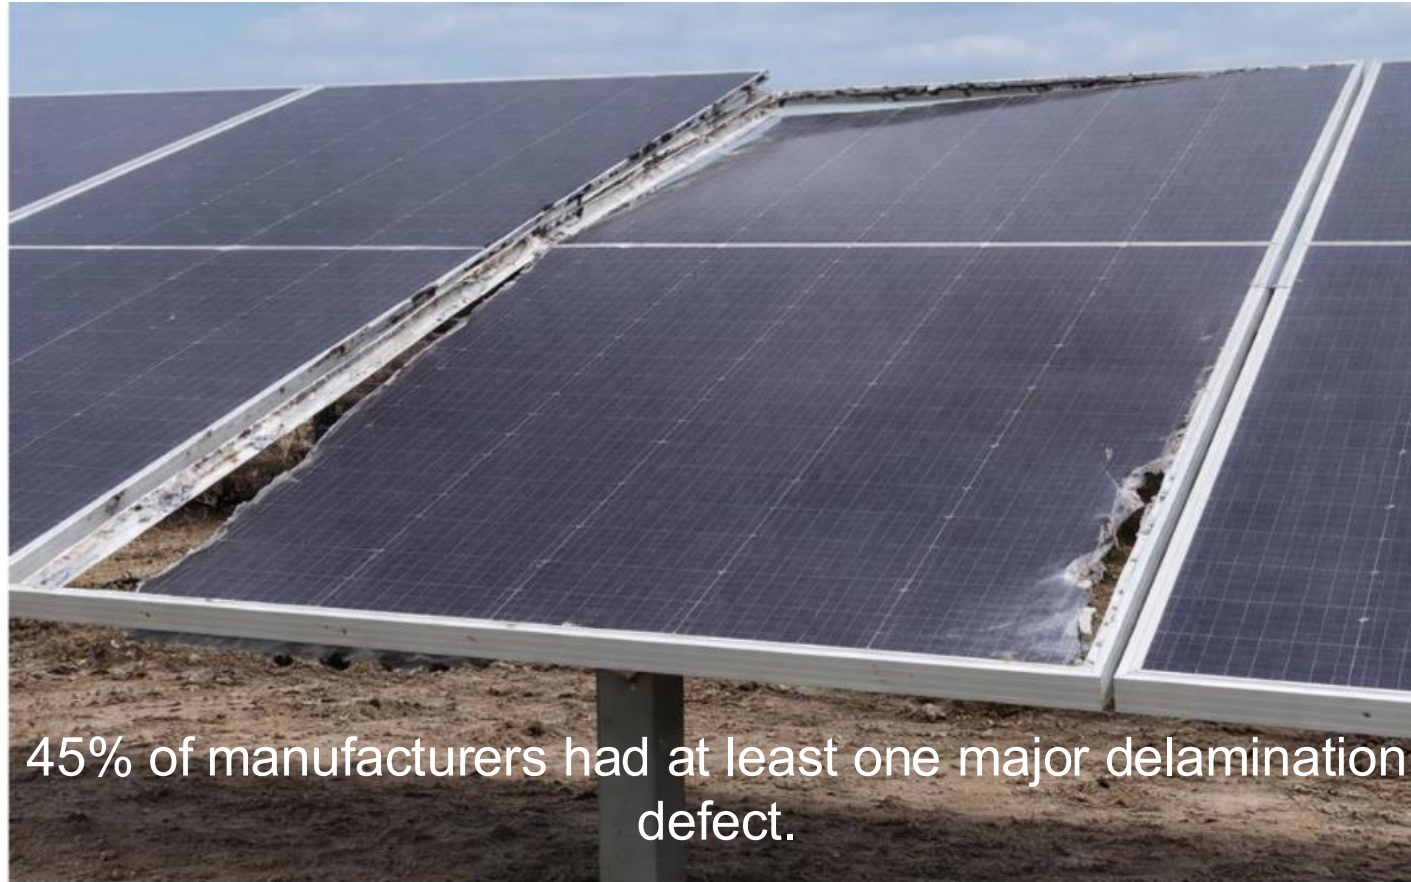
Compromised creepage distances can lead to catastrophic field failures, as shown here.

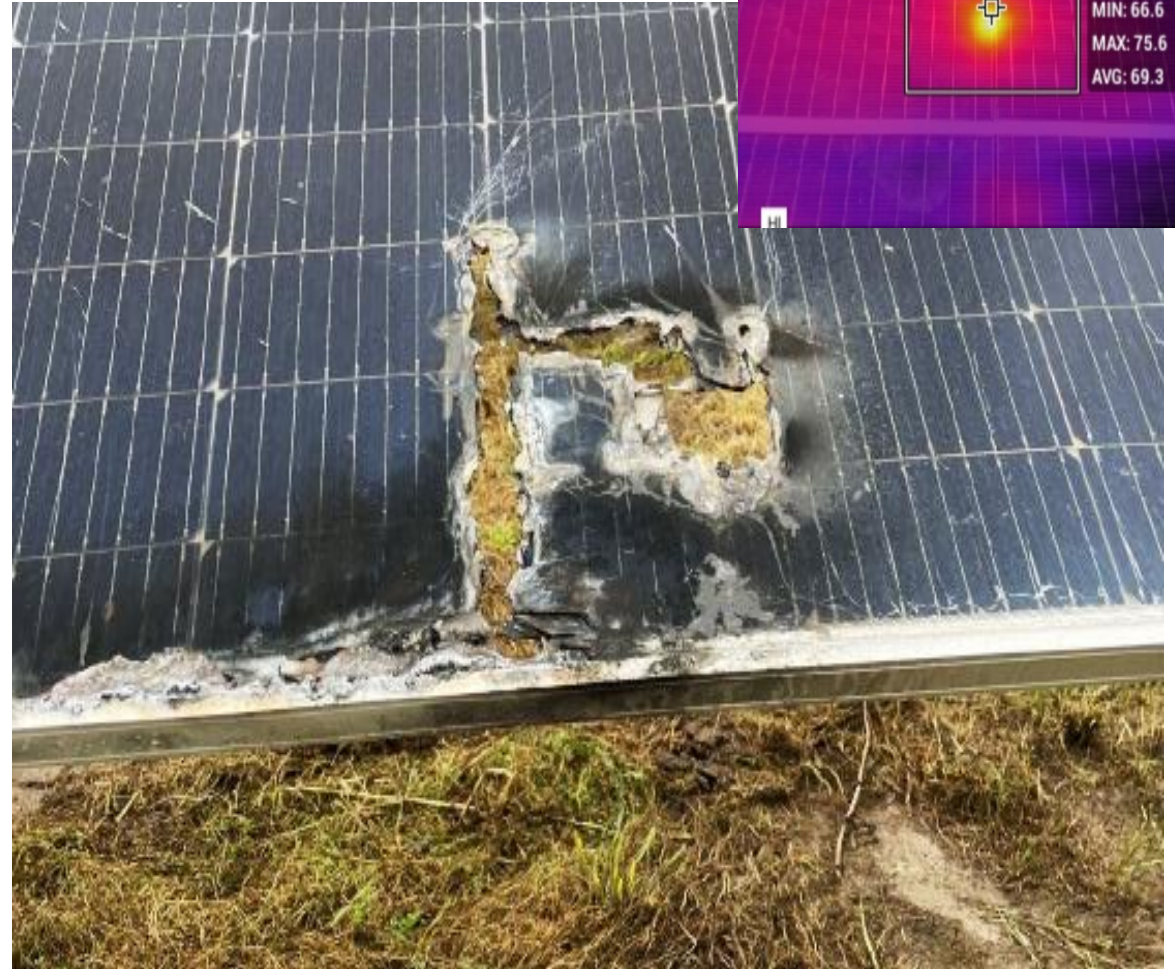
Kiwa PI Berlin's failure analysis team has investigated multiple field incidents over the past year where inadequate inter-cell distances were identified as a root cause.

- Fire due to short circuit formed by contact between two strings of opposite polarity.
- Visual inspection revealed many modules failed IEC/UL 61730 requirements.
  - Required creepage distance: 0.3 mm
  - Measured creepage distance: 0–0.2 mm

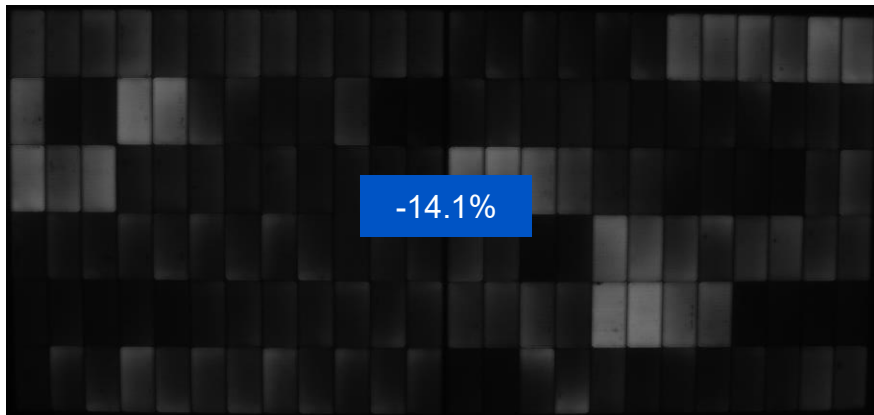
BOM-1 (M10 cells)

UVID is still not solved for many. Example of same module and cell manufacturer, different UVID results:

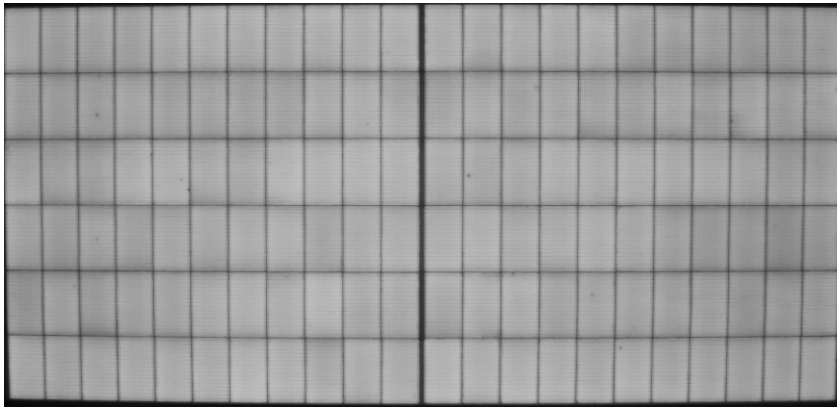
Initial: nothing to see here

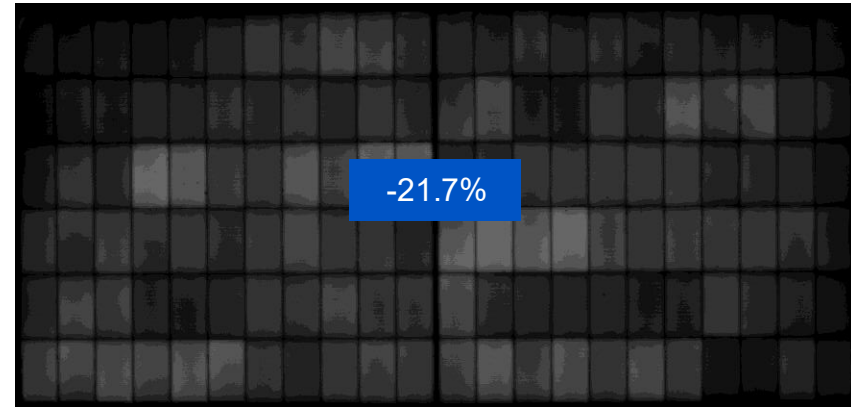
This was the worst case over the past year:

Post-PID192(-): whaaa' happened??

The manufacturer submitted new PQP samples for a PID retest and achieved <2% following PID192(-). This demonstrates that strong quality control of cells is both possible and necessary to ensure suitable PID resistance.
