# *Creepage, Clearance, and Compliance*

## Quality Assurance Lessons from Domestic Manufacturing

**Terry Jester**

**Kiwa PI Berlin**

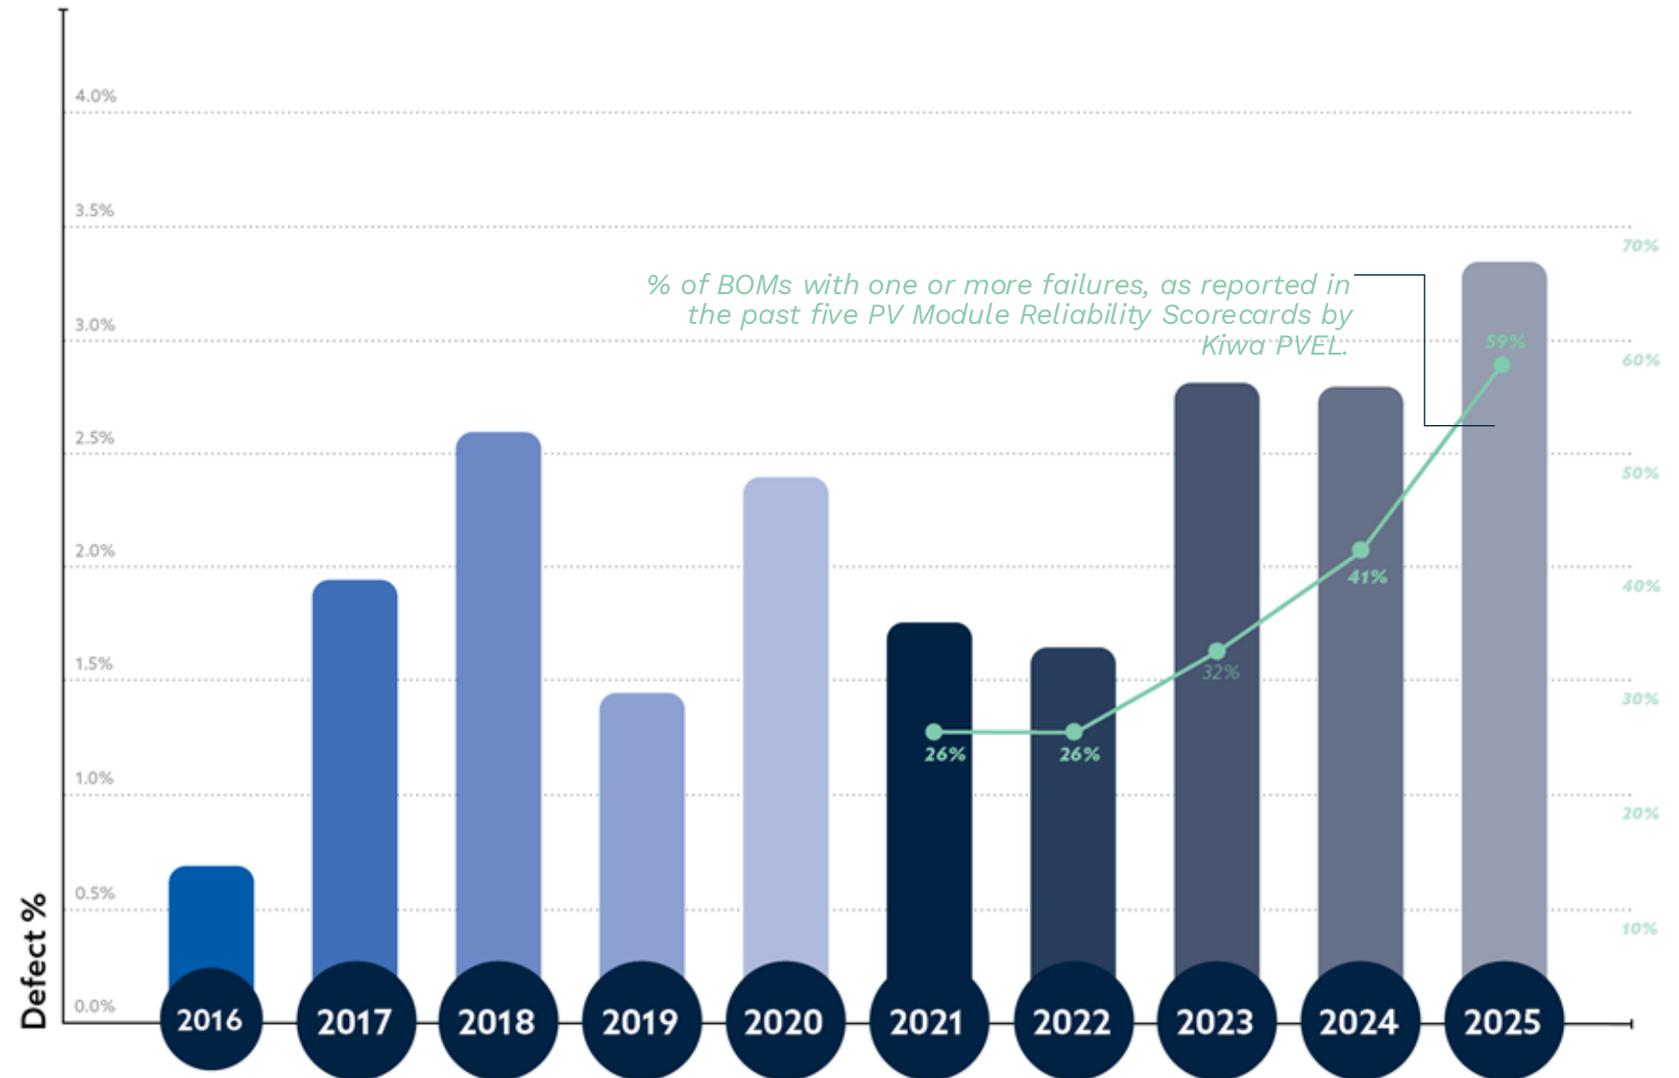
- Kiwa PI Berlin maintains a decade-long defects database spanning 125+ manufacturers, enabling industry-wide benchmarking of PV module quality.
- The graph shows consolidated PSI defect ratios across all inspected factories, illustrating year-over-year quality trends.
- Rising BOM-related issues also appear in Kiwa's PQP/lab testing, with a clear increase in BOM-linked PQP failures mirroring higher PSI defect rates.

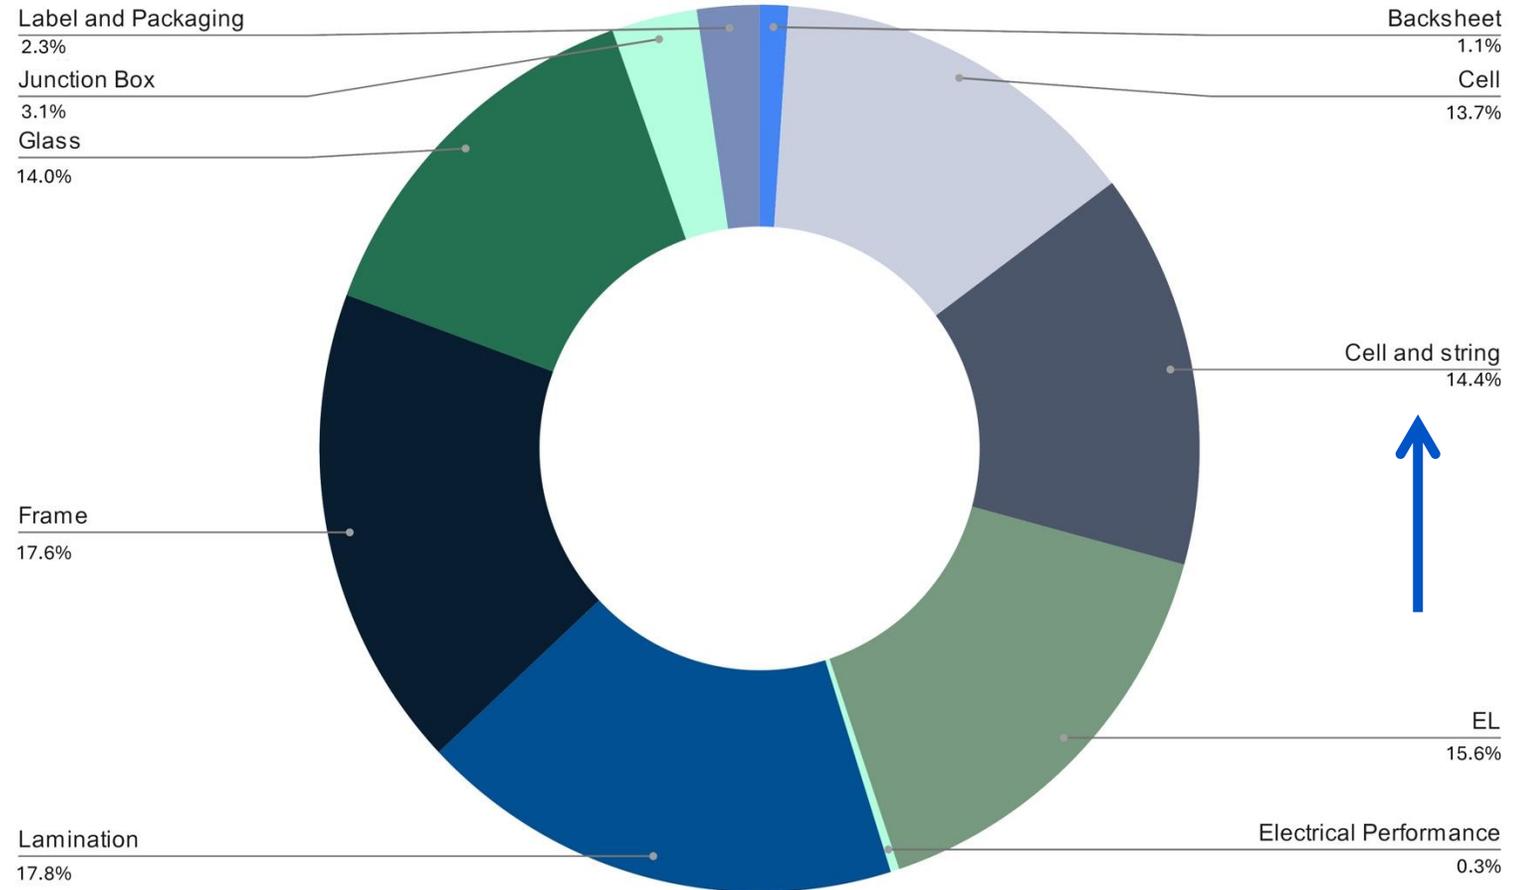
Pre shipment Inspection Observed Defects 2025

- The majority of defects originate from lamination, cell and string interconnects, cells, frame, and glass, accounting for over 75% of observed issues.
- The ratio of some high-risk defects has increased significantly in recent years due to new module designs and BOM changes.
- Overall defect trends highlight challenges in material selection, process control, and equipment calibration.
- Persistent gaps in inspection and monitoring allow high-risk modules to enter the field, despite the increasing number of reported failures, one focus for the industry continues to be in **cell spacing**.

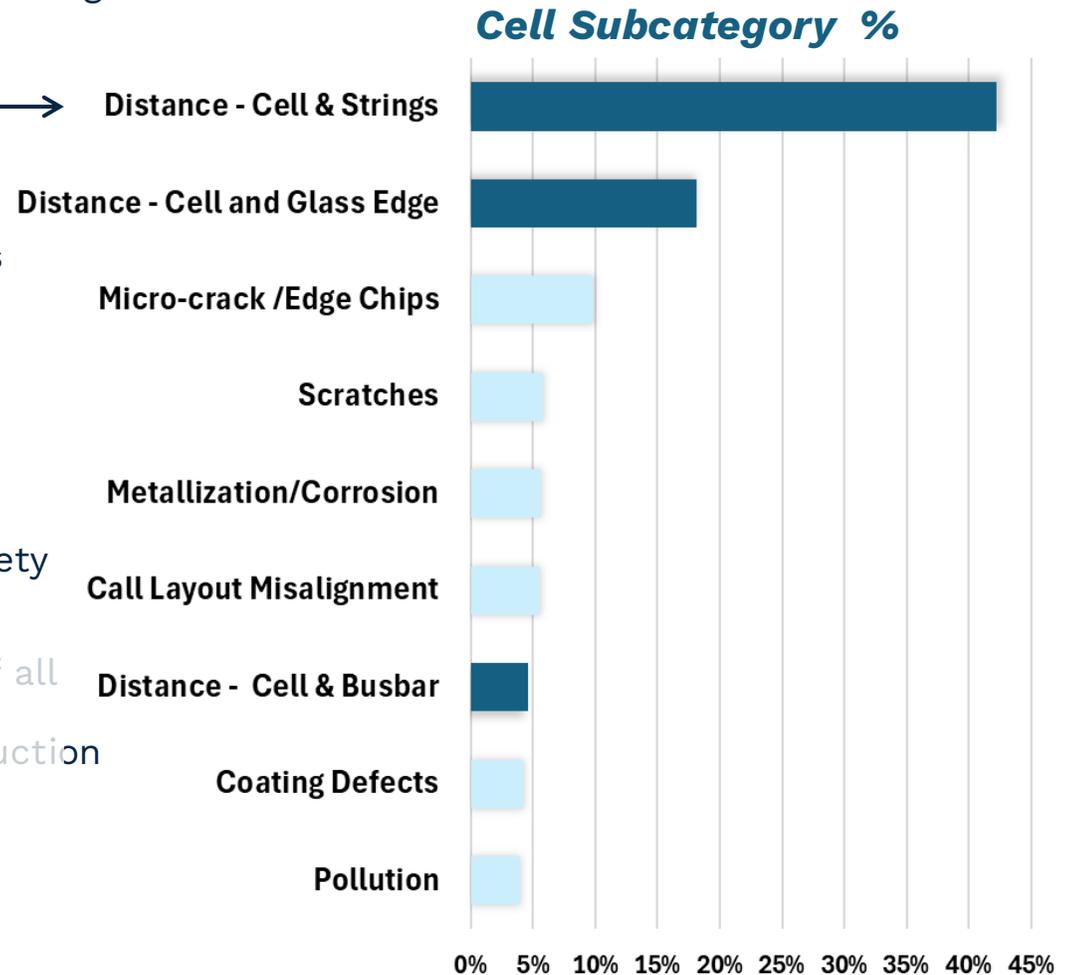
**Most Significant Defect Category** (65% of total findings of cell processing)

- Cells ↔ adjacent cells / cell strings → 43%
- Cells ↔ glass edge → 18%
- Cells ↔ busbars → 5%

Domestic manufacturing-related defects represented over ~40% of all instances of this defect type in Kiwa PI Berlin's global 2025 dataset, highlights a significant quality-control gap within U.S. production lines relative to broader international manufacturing performance.

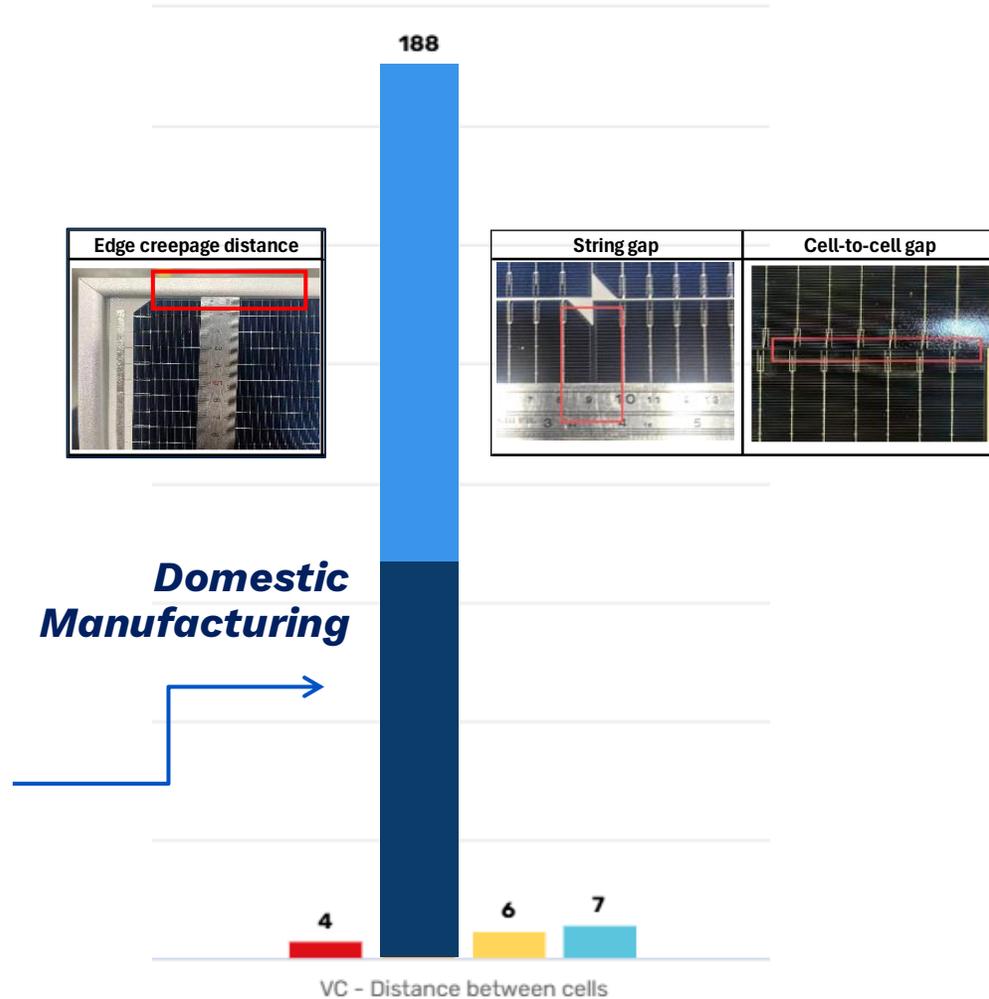
**Most Significant Defect Category** (65% of total findings of cell processing)

- Cells ↔ adjacent cells / cell strings → 43%
- Cells ↔ glass edge → 18%
- Cells ↔ busbars → 5%

**Domestic manufacturing-related defects represented over ~40%** of all instances of this defect type in Kiwa PI Berlin's global 2025 dataset, highlights a significant quality-control gap within U.S. production lines relative to broader international manufacturing performance.

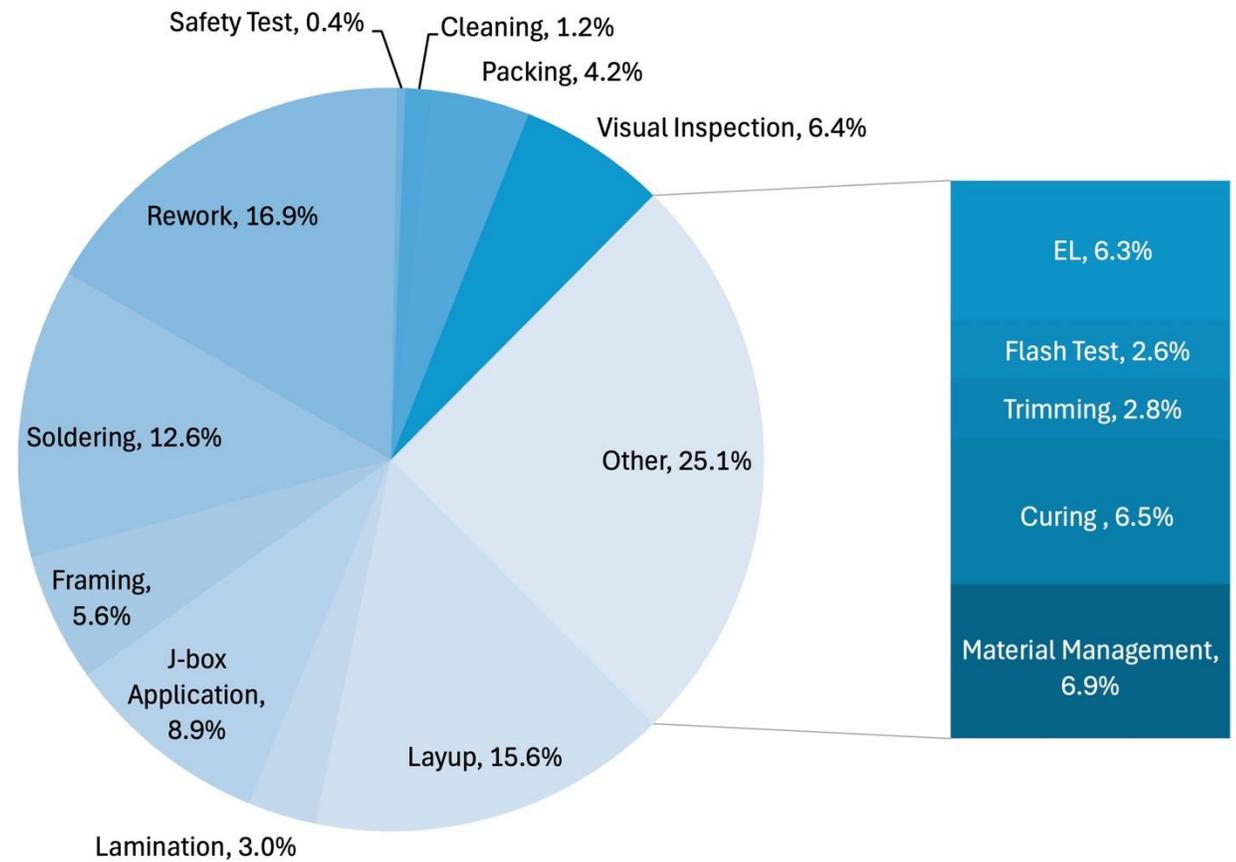
*Production Oversight findings 2025*

- Overly tight spacing design without allowance for equipment tolerances
- Equipment calibration/alignment not maintained to the required accuracy (Layup – 16%)
- Limited awareness of safety and field-failure risks (Rework – 17%)
- Inadequate engineering inspection criteria and screening in QA/PSI (Visual Inspection – 6%)

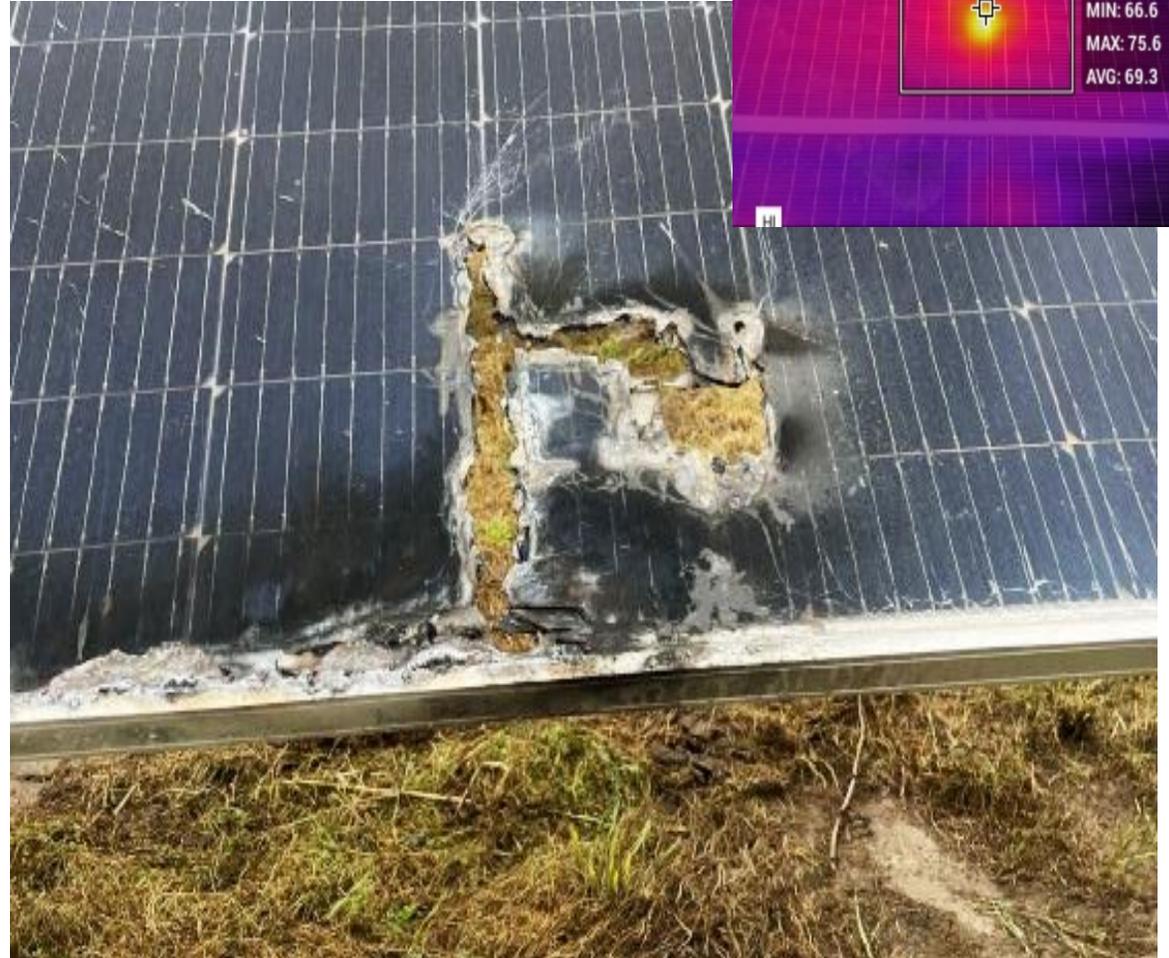
- Fire due to short circuit formed by contact between two strings of opposite polarity.
- Visual inspection revealed many modules failed **IEC/UL 61730** requirements.
  - Required creepage distance: 0.3 mm
  - Measured creepage distance: 0–0.2 mm

Kiwa PI Berlin's failure analysis team has investigated multiple field incidents over the past year where inadequate creepage distances were identified as a root cause.

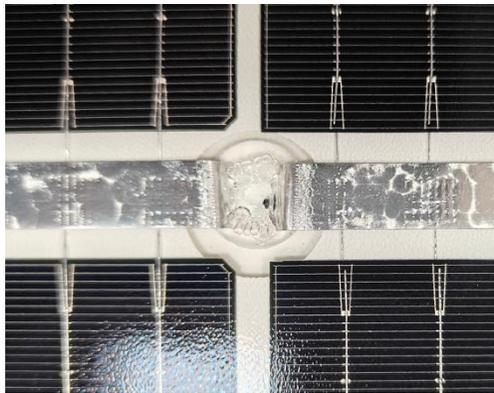
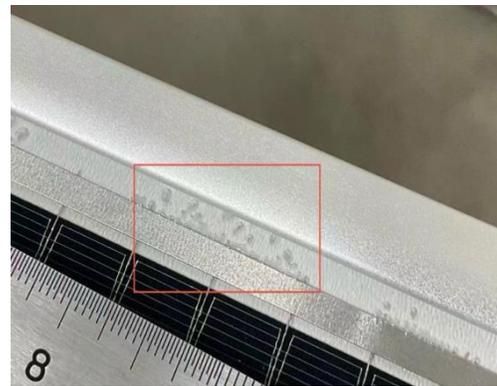
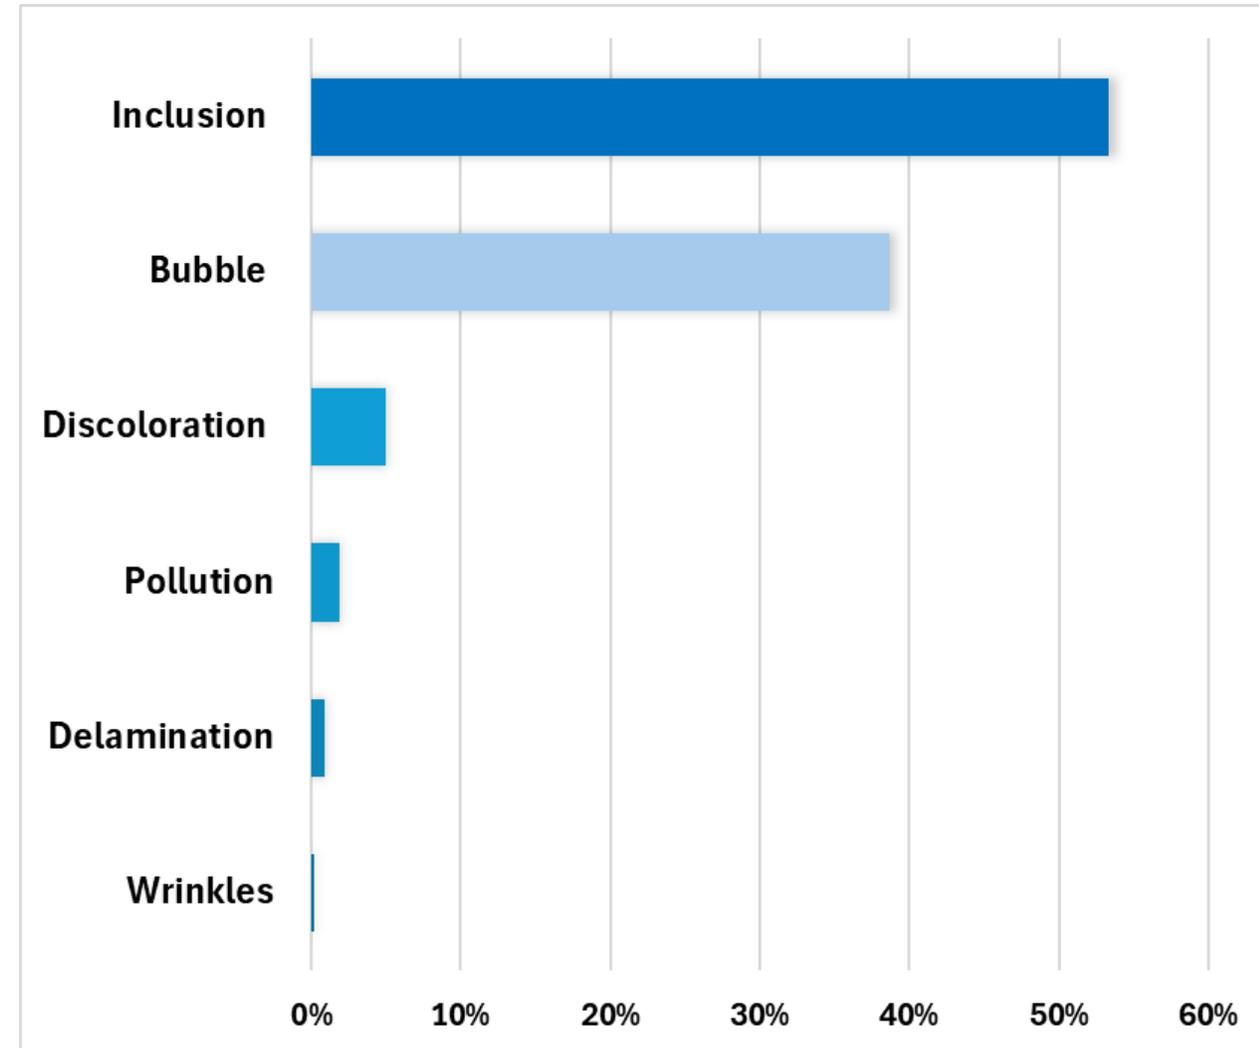
**Based on UL 61730, bubbles are assumed to be conductive. So, High-risk bubble locations are:**

- Bubbles between two live parts
- Creepage areas (edges of the module)
- Bubbles are among the most prevalent lamination defects.
- Edge-located bubbles significantly increase the risk of delamination and compromise the UL/IEC safety requirements for creepage distance.

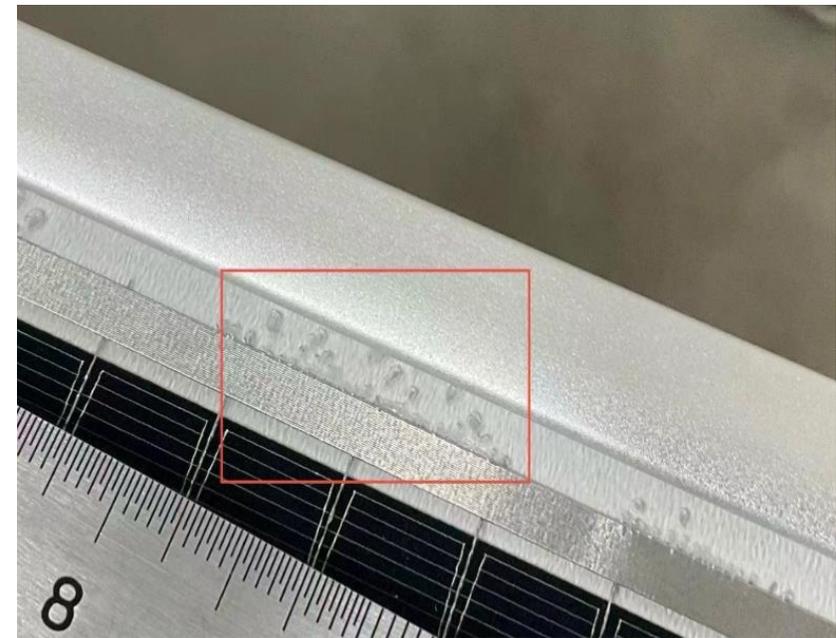
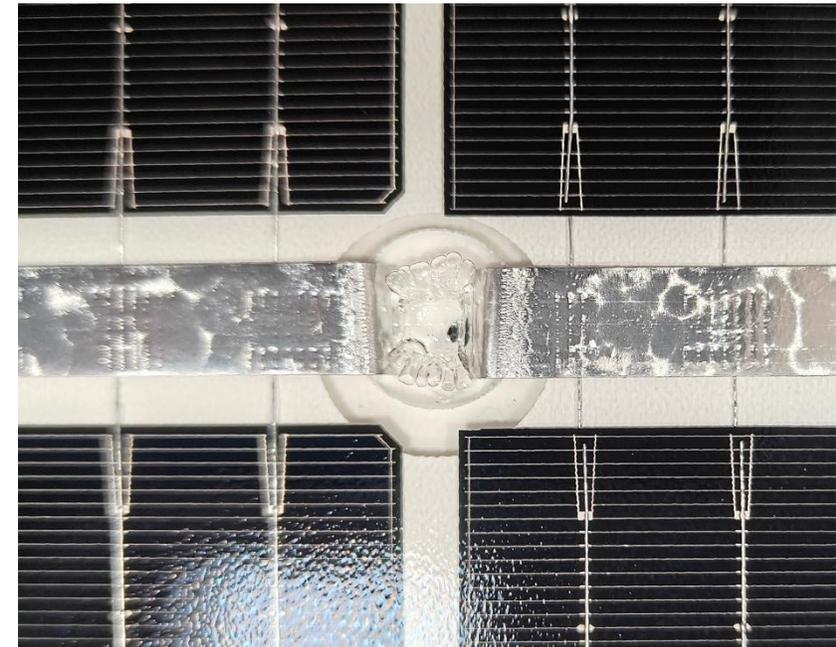
- Improper storage conditions for encapsulant materials.
- Failure to follow shelf-life and use of expired materials.
- Operation of the laminator outside standard process parameters (temperature, time and pressure).
- Poor equipment condition, inadequate maintenance, or lack of proper calibration.
- Edge pinching.
- Reduced encapsulant thickness and dimensions as a cost-saving measure.

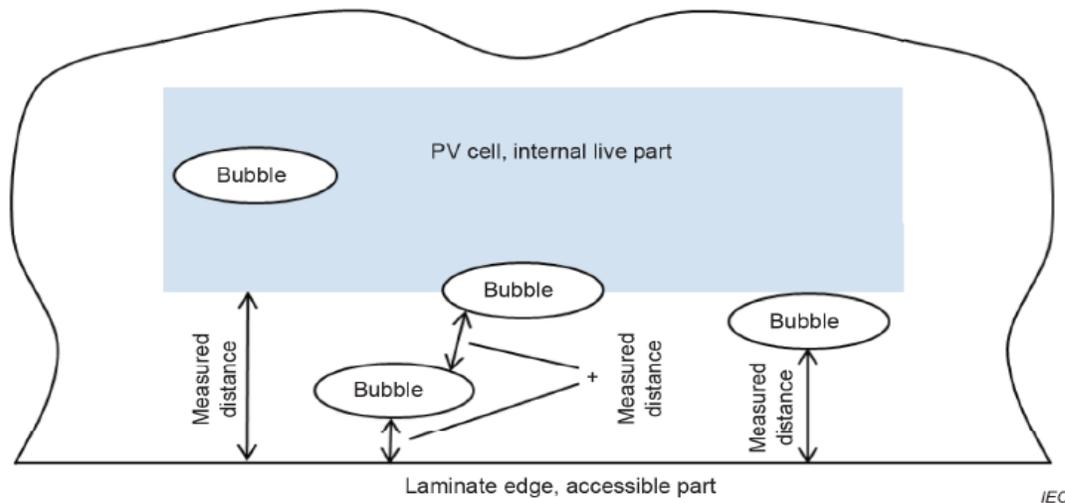
- Based on UL 61730, bubbles are assumed to be conductive.
- Bubbles can compromise the required creepage distance.
- This condition can lead to a short circuit and potential safety risk.

a) Example for delamination assessment when measuring creepage distances and clearances, or distance through insulation

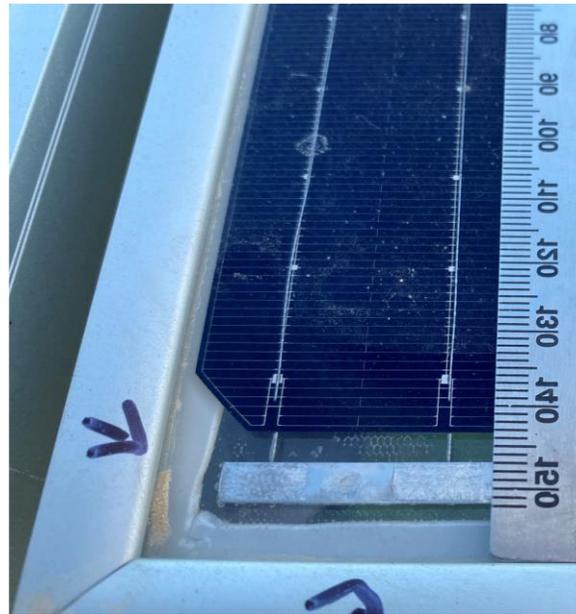
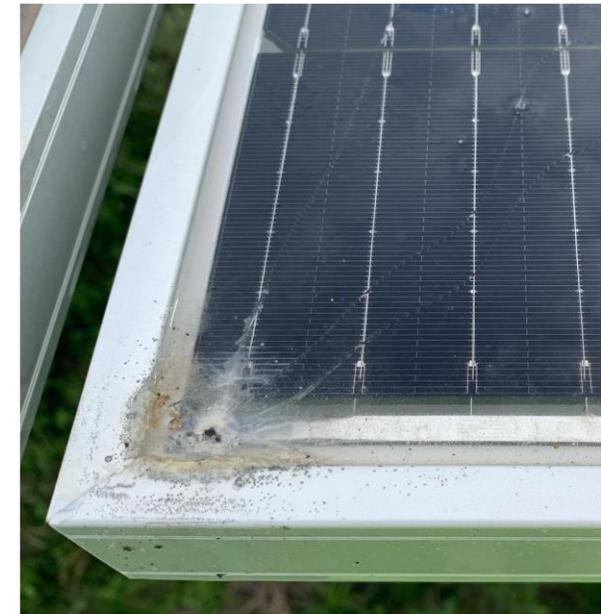
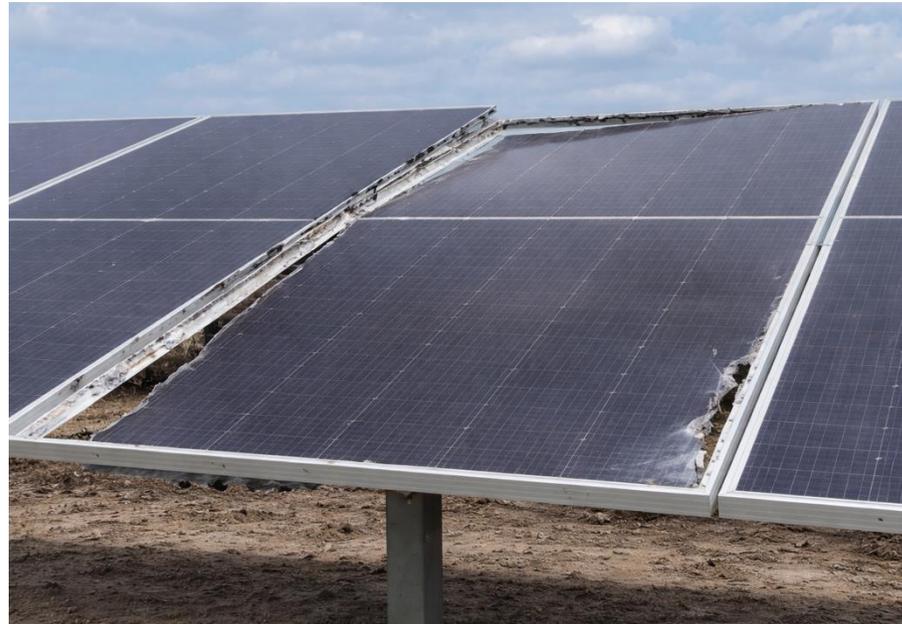
- Bubbles at the glass edge compromised the required creepage safety distance (UL/IEC 61730-1: 10.4 mm for 1500 V modules).
- A continuous conductive path formed between the internal electrical circuit and the frame.
- Insufficient creepage distance resulted in electrical arcing and subsequent fire failure.

*Images show field failure sequence illustrating this mechanism step by step.*
