ENERGY-TO-FAILURE TO ASSESS THE QUALITY OF ELECTRO FUSION JOINTS IN PE PIPES

Frans Scholten (frans.scholten@kiwa.nl)

Kiwa Technology, PO Box 137, 7300 AC, Apeldoorn, Netherland.

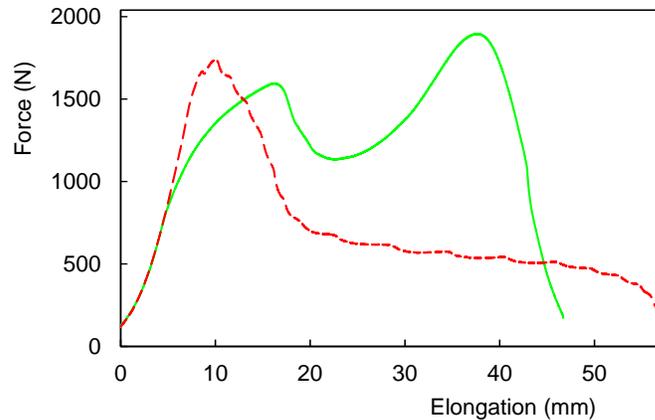
A second evaluation method is based on the force-displacement curve measured during the Peel test. Usually these curves are not recorded, but they are informative. Figure 8 shows two typical examples. From these curves the maximum force and elongation were determined and used as a quality criterion (columns 5 and 6 in Table 2).

Figure 8. Typical examples of the force versus the displacement of peel test bars. The Failure Energy (Joule/mm) is the area under the curve (Joule), divided by the width of the test bar (mm).

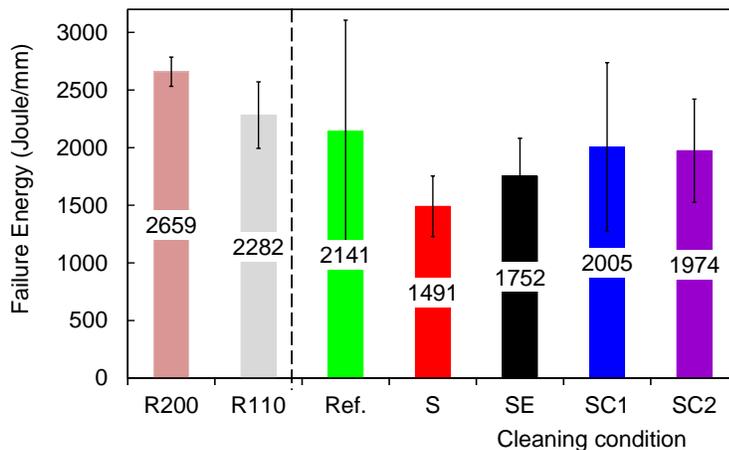
The EtF was determined from the already measured force-displacement curves. The average EtF per condition is given in Figure 9. There is some indication that the thicker wall of the 200 mm pipe (condition R200) leads to a higher EtF value.

Figure 9. Failure Energy (Joule/mm) for different contamination and cleaning conditions. R200 and R110 are non-contaminated reference joints from another investigation which give similar results to Ref. Average value per condition given at half height of each column.

The Failure Energy of the test bars contaminated with silicone spray (S) is lowest with respect to condition Ref. Cleaning with ethanol provides some improvement. However, the commercial silicone cleaners perform best. There is nevertheless much scatter in some of the data.

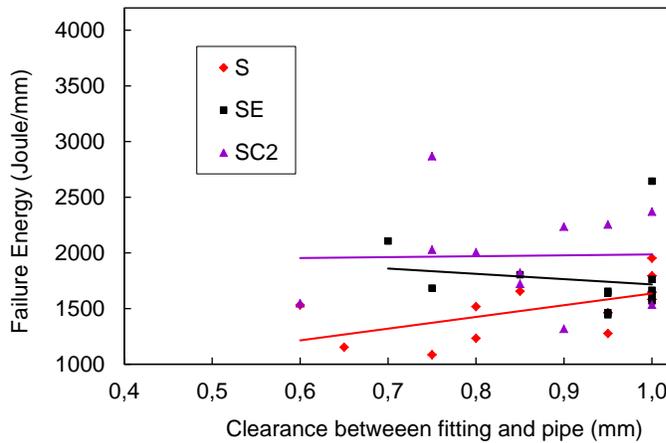
This scatter can be partially explained by the influence of the clearance between the outer surface of the pipe and the inner surface of the fitting. This clearance, which is caused by ovality of the pipes, was measured for every test bar in every condition. Figure 10 shows that in conditions S, SE and SC2 (contaminated and not-optimally cleaned) the Failure Energy is not influenced by the clearance. However, in conditions Ref and SC1 (clean and optimally cleaned) there is a certain upward trend in Failure Energy with decreasing clearance (Figure 11) although the scatter is still large. Moreover, some rather high EtF values are measured for these conditions. It would appear that the Failure Energy method allows subtle influential factors to be detected and hence provides more results which are also quantitative.

Figure 10. Failure Energy versus clearance between fitting and pipe as measured around the circumference of the joint in the conditions S, SE and SC2.

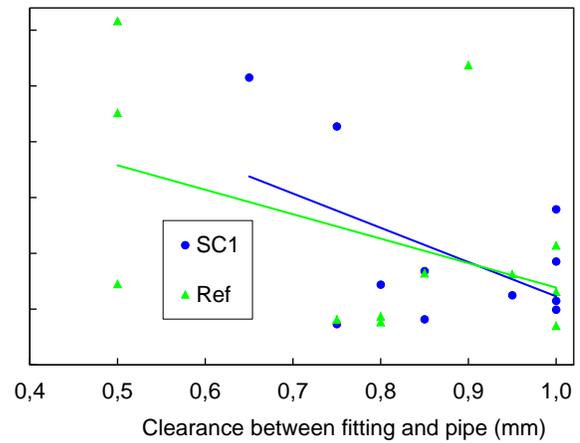
Figure 11. Failure Energy versus clearance between fitting and pipe in the conditions SC1 and Ref.

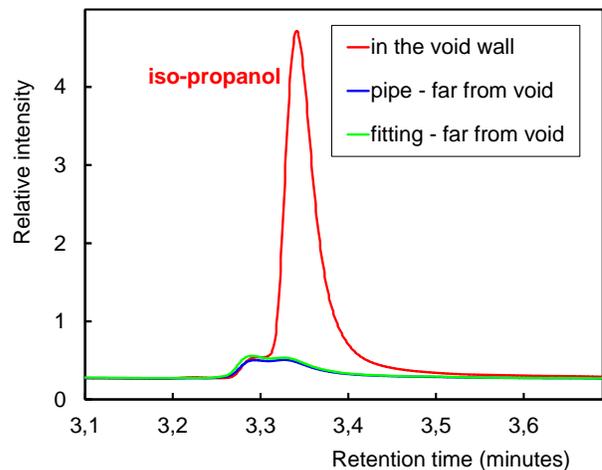
An unwanted phenomenon occurred during electro fusion work performed in the autumn (November) when constructing a new PE100 gas pipeline. A hissing sound was noted during fusion. The joints were cut out and inspected on site. Several unusual voids near the joint plane were observed with the naked eye (Figure 12). In the lab newly-cut samples were taken out of another part of the joint, which revealed more voids. A sample was cut from the wall of such a void. Two more samples were taken from the pipe and the fitting, in both cases far away from the voids. GC/MS analysis was performed only a few hours after cutting. The samples were heated at 210 °C during 15 minutes. Analysis of the vapours (Figure 13) revealed a large peak of a substance evaporated from the first sample that was absent in the latter two samples. MS identification proved that the large peak was due to the presence of isopropanol.

Figure 13. GC curve of three samples in an electro fused joint with vapour voids. Identification was made using MS.

Isopropanol had been recommended by the fitting manufacturer as a replacement for ethanol. However, no allowance had been made for the longer drying time needed for isopropanol in the given weather

conditions (6 minutes instead of some seconds for ethanol). Because the short drying time intended for ethanol as prescribed in the jointing protocol was not amended, isopropanol did not have the time to evaporate completely. The high fusion temperature provoked evaporation of the isopropanol, which subsequently gathered to form vapour bubbles in the molten PE. These did not disappear during cooling of the joint. This led to the formation of the voids.
