QUALITY CONTROL OF JOINT INSTALLATION IN PRE-INSULATED PIPE SYSTEMS

E.J.W. van der Stok

Kiwa Technology, Apeldoorn, the Netherlands

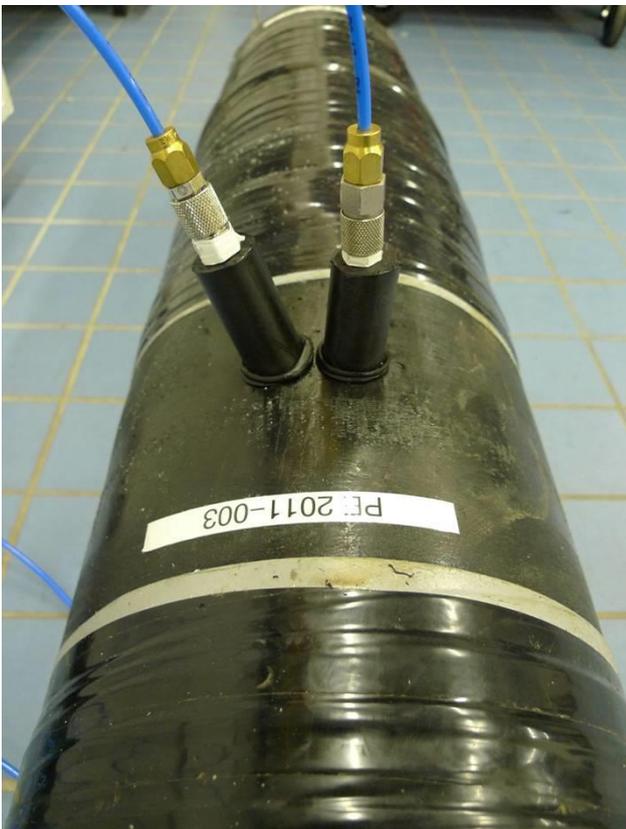
Figure 3. Connections to a district heating pipe joint using two hollow PE rods to perform the leak tightness test.

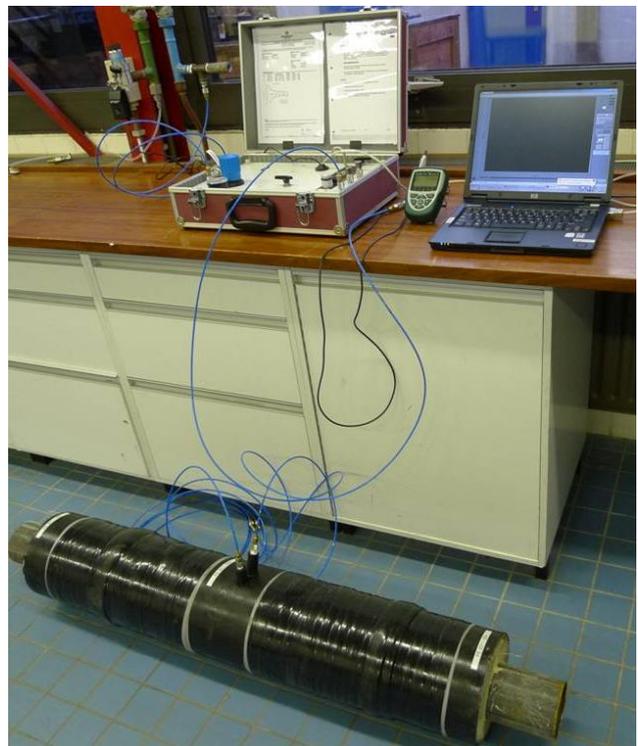
Figure 4. A district heating pipe joint is pressurised; the pressure and flow are measured.

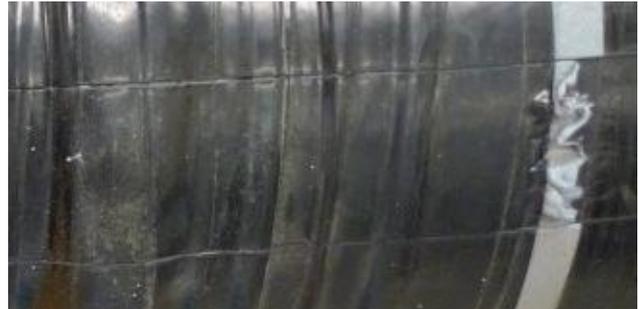
In more than 50 % of the PE shrink joints, one or more tape strips could be peeled away from the casing and/or PE shrink sleeve (compare Figure 11 with Figure 12). It was often found that the pipe ends and PE sleeve were not properly abraded. Improper abrading can therefore result in a low bonding strength of the tape, which decreases the quality of this water barrier and thus increases the possibility of water entering the joint.

Figure 12. These tapes were strongly bonded to the PE casing. The edge on the right side shows unsuccessful attempts to detach the tape.

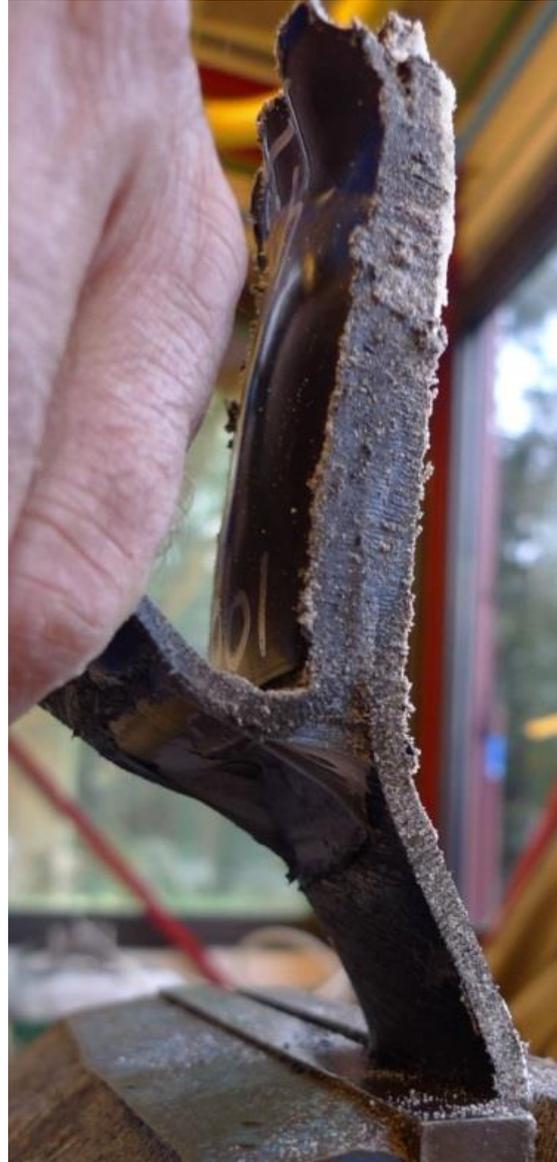
Only about 15 % of the collars in the PEX shrink joints could be peeled away from the casing and/or PEX shrink sleeve manually (Figure 13). In slightly more cases (about 20 %) the PEX shrink sleeve could be peeled away from the casing manually (compare Figure 14 with Figure 16). Insufficient heating, insufficient abrasion and/or contamination, e.g. by sand, of the joined surface are expected to be the principle causes of the poor adhesion. In the other cases the PEX sleeve and shrink film all had strong bonds with the PE casing. In each of these cases considerable force was needed to separate the various components at room temperature.

Figure 16. The bonding between the PEX shrink sleeve and the PE casing is strong enough to withstand manual peeling.

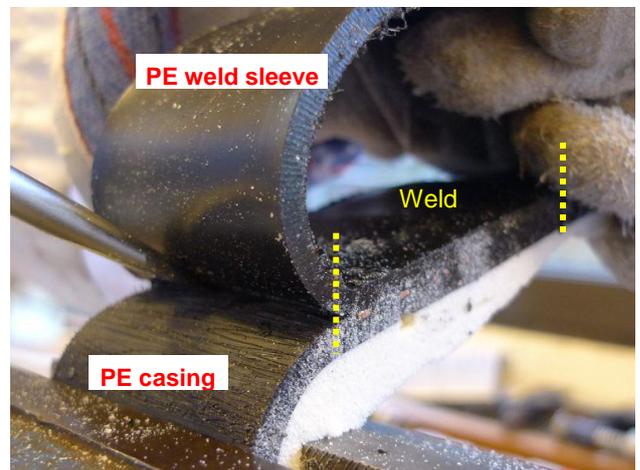
Surprisingly, over 60 % of the welded joints could also be manually peeled away from the PE casing (compare Figure 15 with Figure 17). In a welded joint, the PE of the casing and sleeve are melted together to form a very strong bond.

Figure 17. The weld is strong enough to withstand manual peeling.
