Non-Destructive Ultrasonic Inspection to Detect Flaws in Plastic Pipe Walls and Joints – Correlation with Lab Testing

Frans L. Scholten, (frans.scholten@kiwa.nl), Kiwa Gastec Technology,
PO Box 137, 7300 AC Apeldoorn, the Netherlands,
Hyeon Jae Shin, (hjshin@indesystem.com), Inde Systems,
300 Chonchon-dong Suwon, 440-746, South Korea.

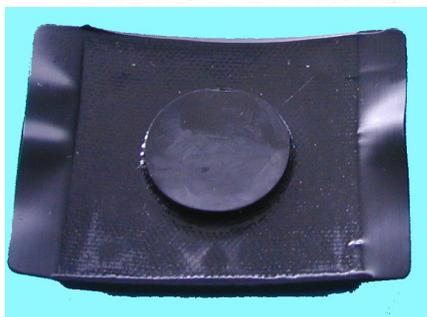
Below: Enlargement of such a plug (yet unused), upside down. The required fusion zone is at the circumference of the slightly tapered cylindrical part.

Some of similar fused plugs in an older district heating system appeared to be leaking due to poor joint quality. This was caused by contamination and poor workmanship.
