# What Solar Module Test Failures Reveal in 2026

## Key Takeaways from Kiwa PVEL's PV Module Reliability Scorecard

Todd Karin, VP of Technology.

9/14/2026. EUPVSEC 2026. Rotterdam, NL

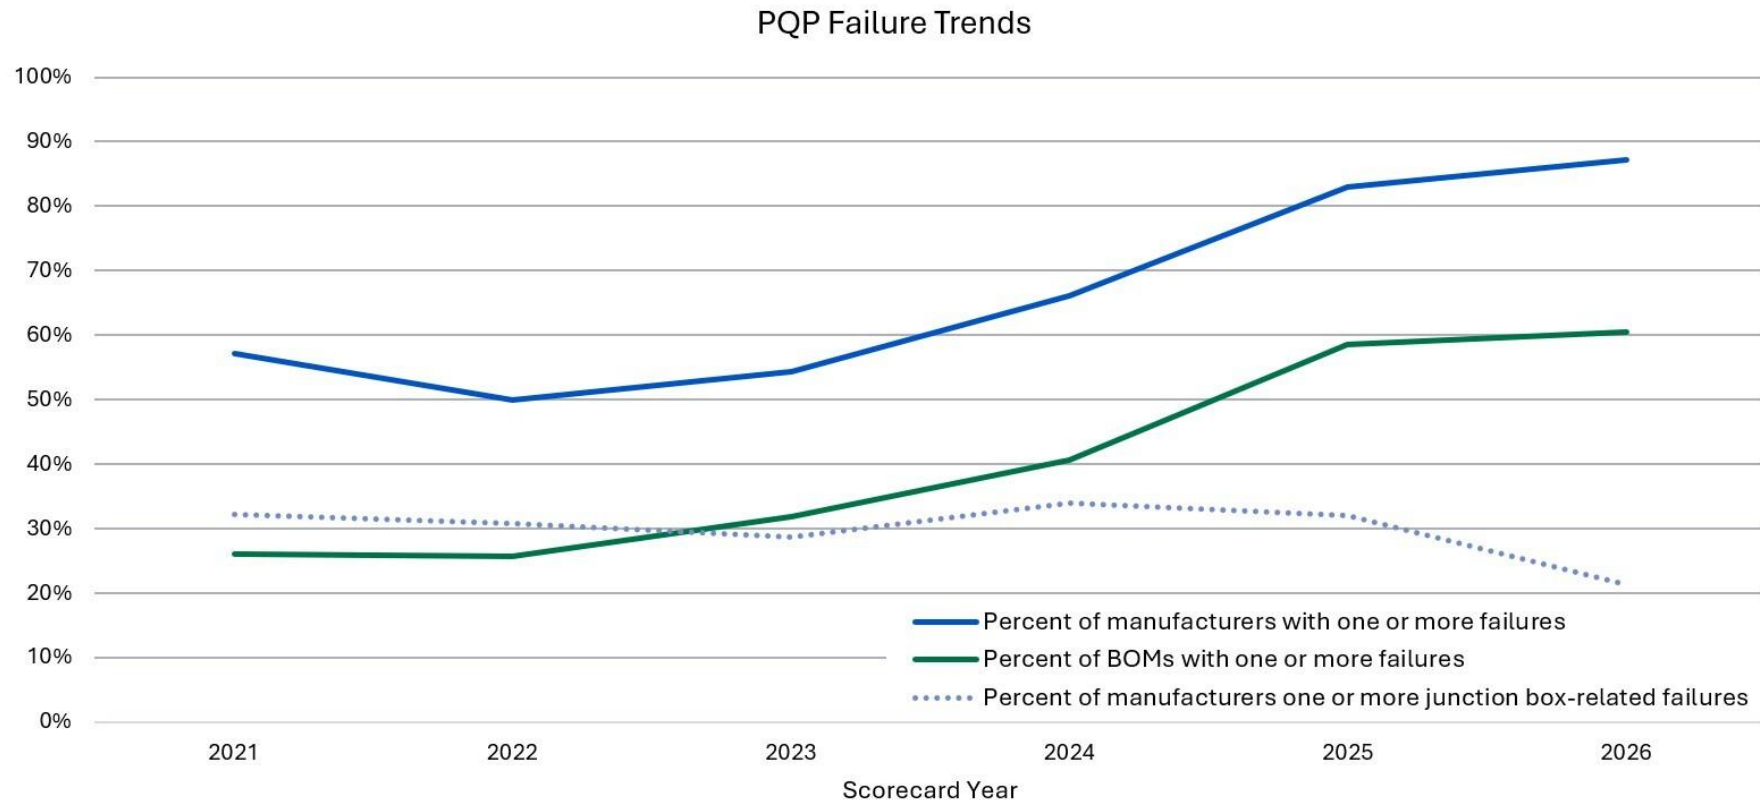
## PQP Failures on the Rise

**PQP failure rate continues to increase** over the past year, with 87% of manufacturers and 61% of BOMs experiencing one or more failures.

**Module breakage** during MSS and HSS (hail) testing continued to be the top failure mode, but a sharp increase in **delamination** defects made it a close second in failure occurrences.

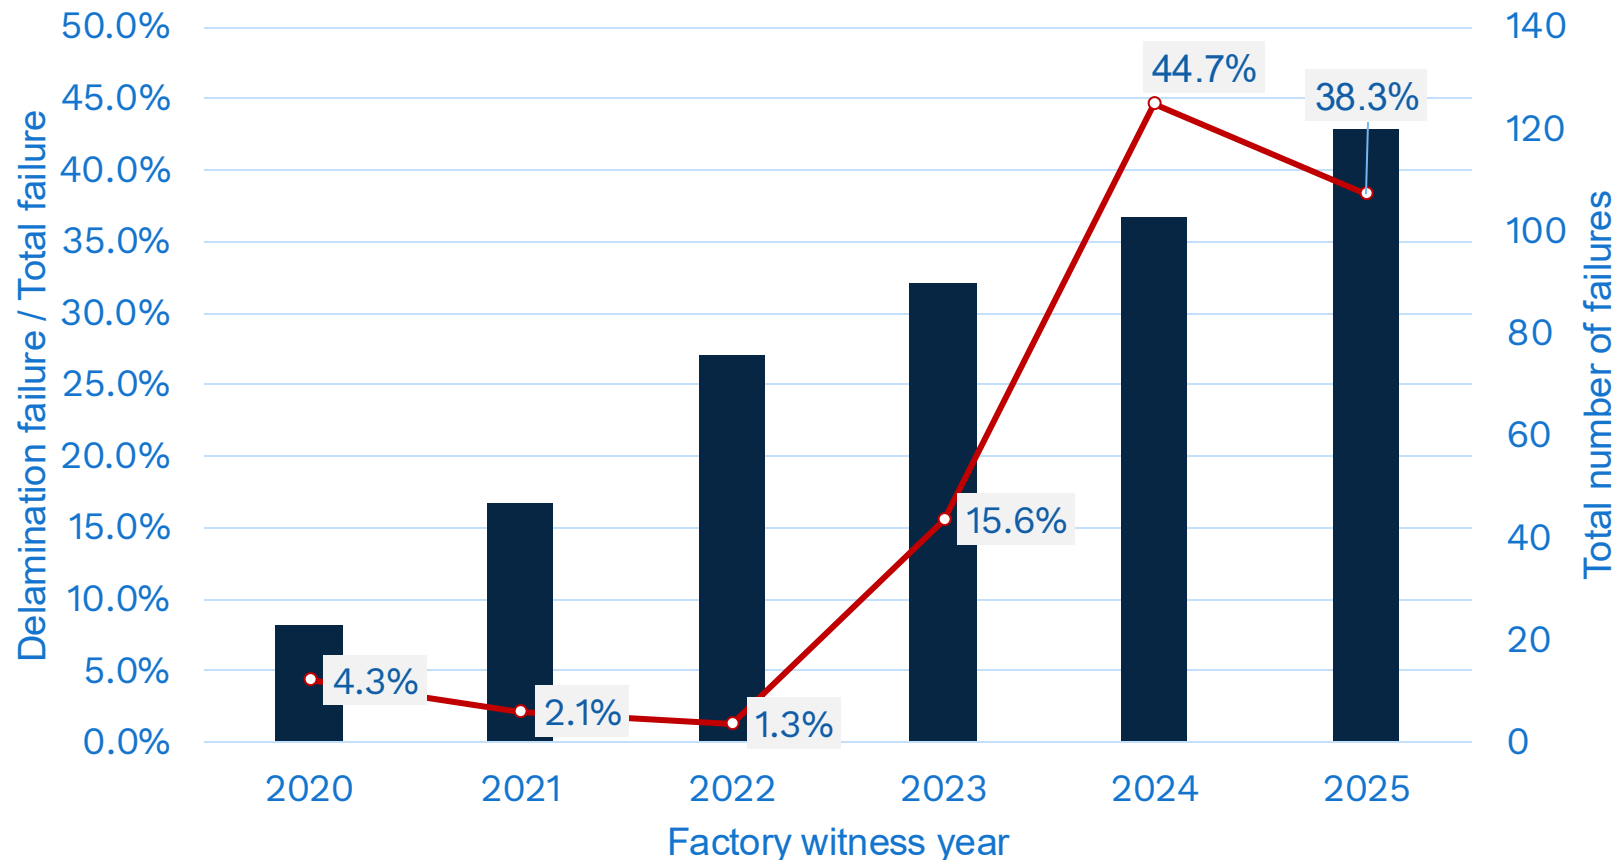
## Delamination – A Rising and Under-appreciated major concern

### **45% of manufacturers had at least one major delamination defect.**

1/3 of these defects came after DH testing (DH1000 or DH2000), but also observed during initial characterizations and after TC, MSS, PID and UVID.

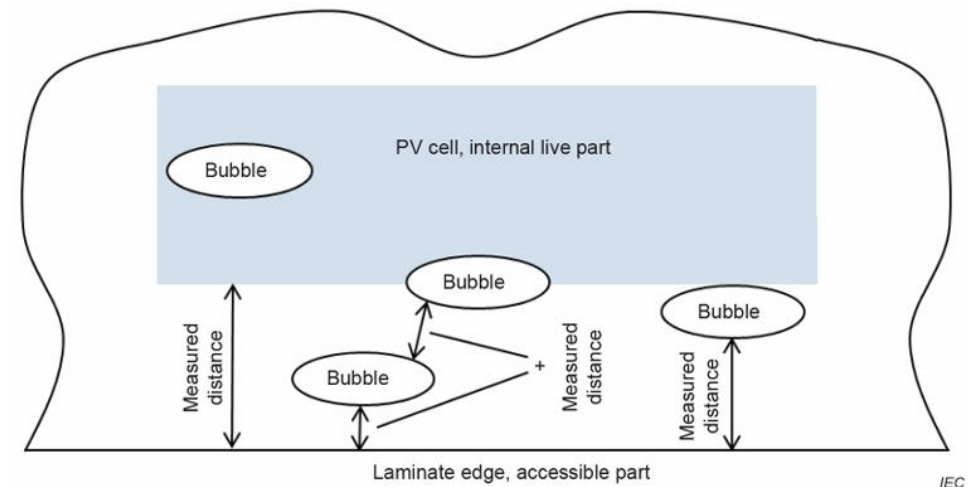
Per IEC61730, bubbles are assumed to be conductive. Considered a Major Defect when creepage distance is below IEC 61730-1 requirements.

a) Example for delamination assessment when measuring creepage distances and clearances, or distance through insulation

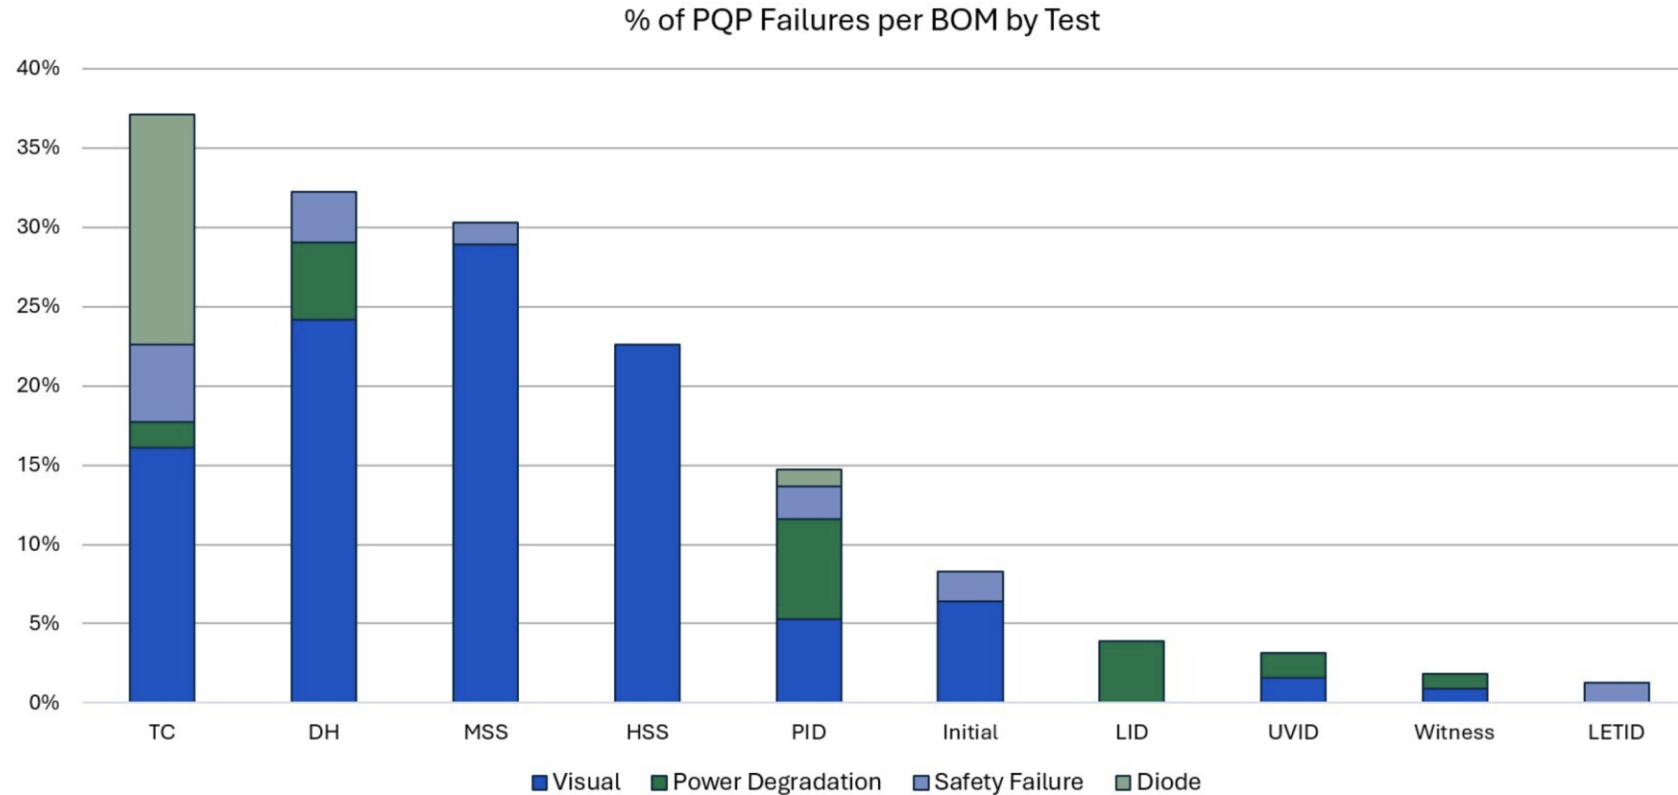
## Failure breakdown by test

The percentage of PQP failures per BOM by test sequence. Initial failures are those that were detected during characterizations prior to stress-testing. Witness failures occurred when the manufacturer decided not to ship the modules following the PQP sample production factory witness due to a quality issue.
