Testing Times for PV Modules

2025's three most common findings in PQP testing

Sishir Garemella, Head of International Business Development
Kiwa PVEL

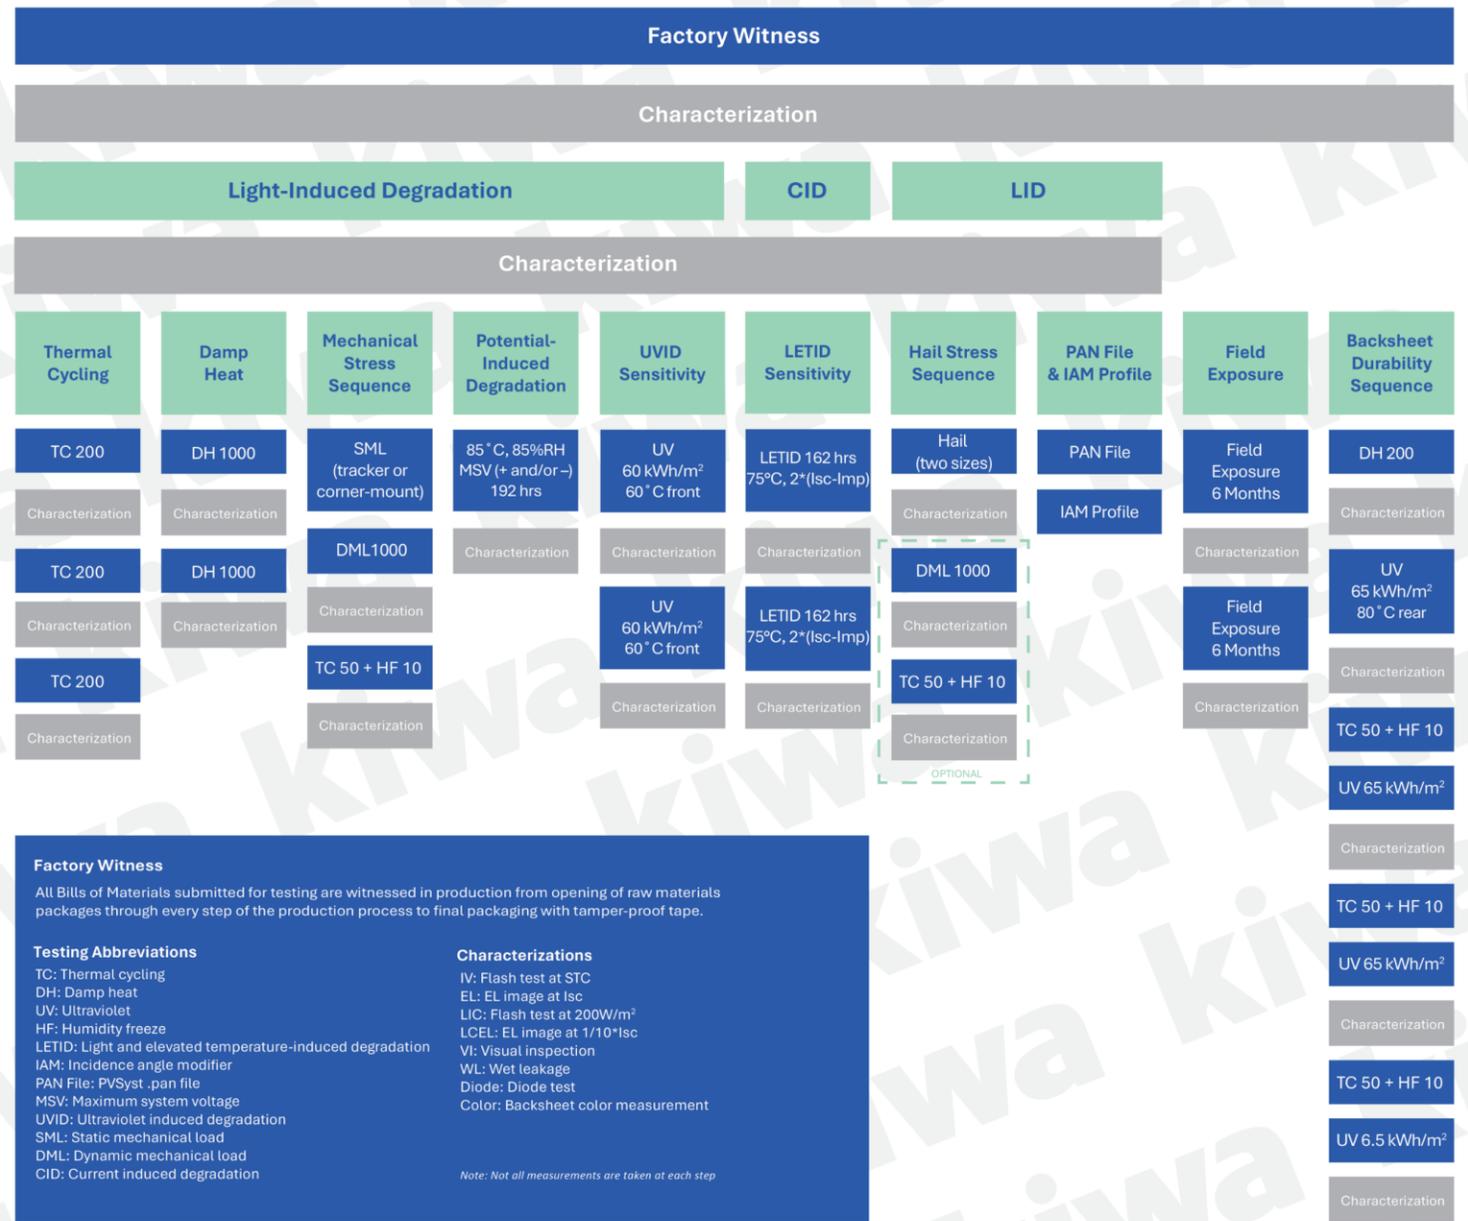
PQP Test Sequence

The PQP evolves every two years based on feedback from Kiwa PVEL’s downstream partners, module manufacturers, and the industry’s collective understanding of module failure modes and test mechanisms.

The most recent update introduced the new UVID test and streamlined many of the tests leading to faster execution of PQP projects.

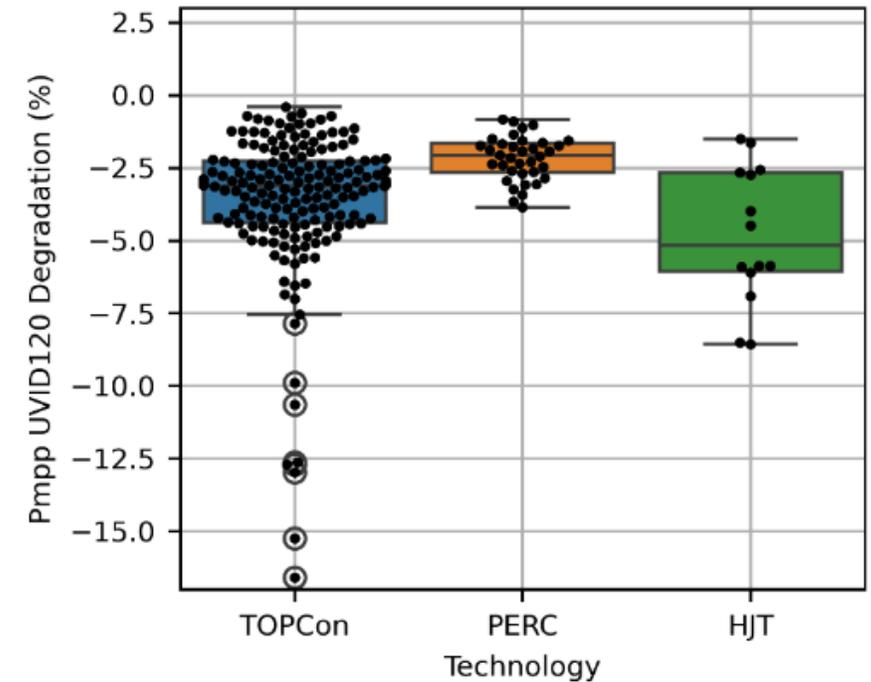
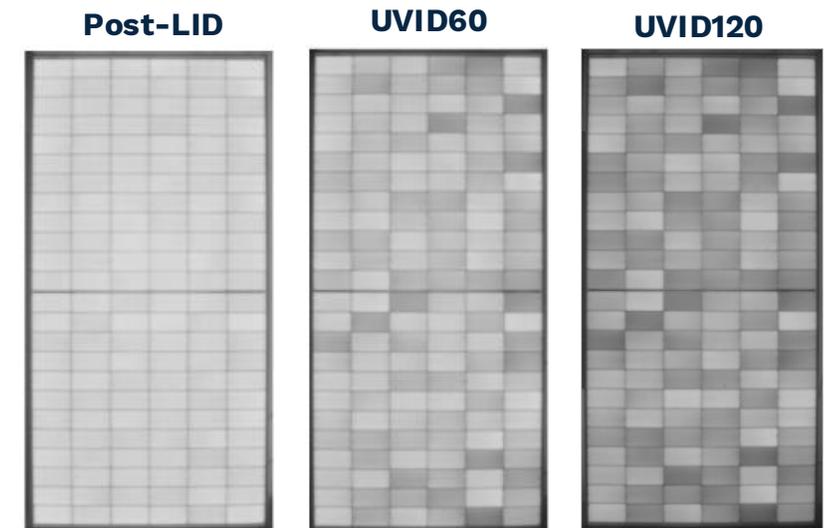
#3 – UVID – Results at a Glance

- Largest “public” UVID dataset (2024-2025):
 - Total **378 modules** (~189 BOMs) evaluated
 - 77% TOPCon modules, predominant technology
- Characteristic **“Checkerboard” pattern** in EL images
 - Cells degrade randomly within the module, with no distinct pattern with position.
- **UVID affects all TOPCon, PERC and HJT modules**
 - TOPCon and HJT modules showed a broad range of susceptibility (0.6% to 16.6%)
 - Indicating the variability in bill of materials, cell architecture, and processes.
 - UVID-stable TOPCon BOMs are available.
- UVID solutions:
 - Front cell ARC/passivation layer process controls
 - UV-blocking front encapsulants or UV down-conversion encapsulants

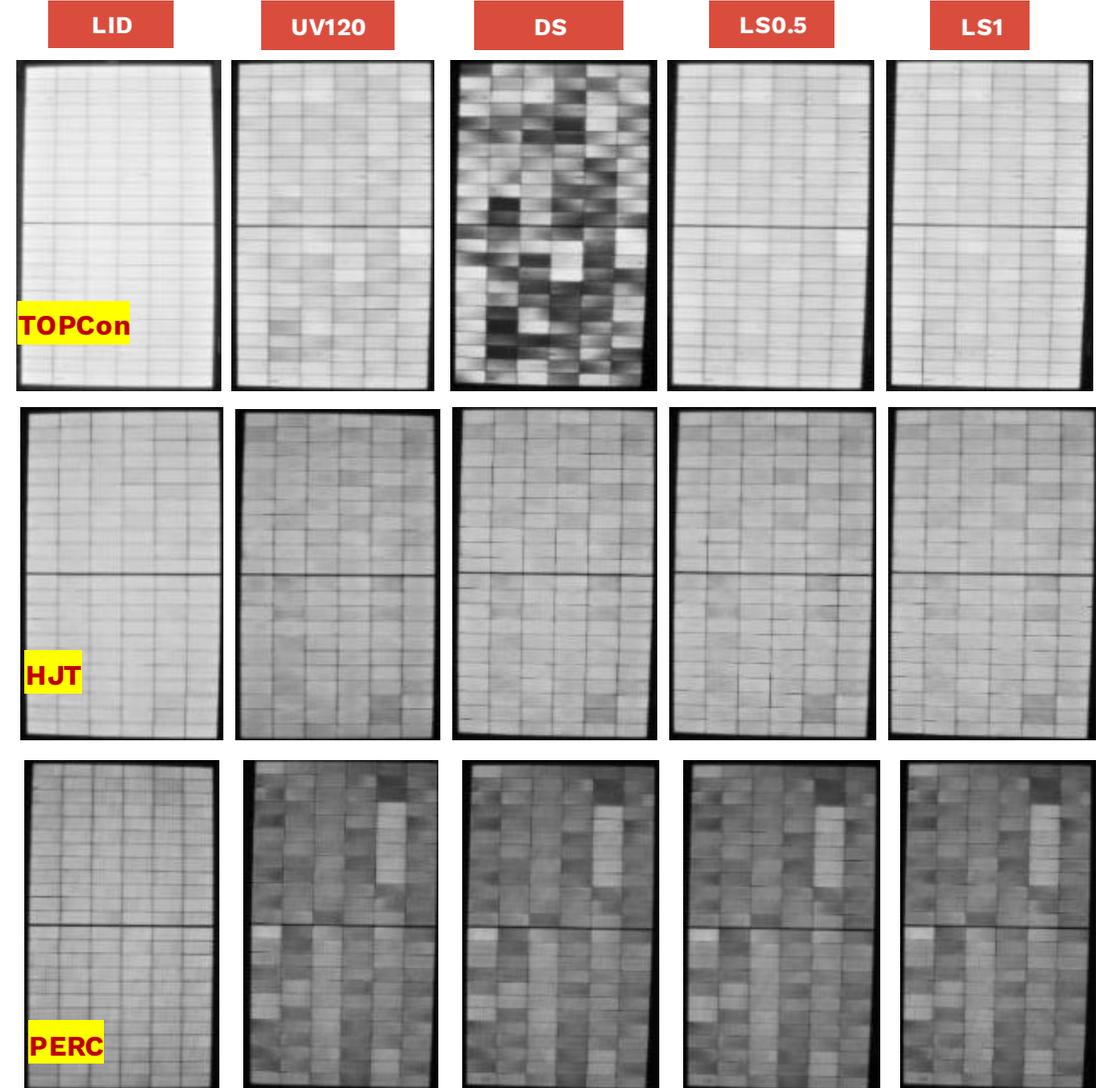
#3 – UVID – Dark Storage Metastability & Stabilization

- UVID-sensitive TOPCon modules suffer from dark storage (DS) degradation (metastability).
 - Greater the dark-storage, higher is the degradation.
- This degradation is recoverable under full spectrum light-soak (LS).**
 - TOPCon - Fast and effective recovery (Voc/Isc/FF).
 - HJT - Obvious recovery but at slower rate (FF).
 - PERC - No obvious degradation or recovery.

LID	UVID120	Dark Storage (60 days)	LS 0.5kWh/m ²	LS 1kWh/m ²
Bad TOPCon	0.40%	-5.60%	-12.30%	-5.70%	-5.60%
Good TOPCon	-0.10%	-1.40%	-2.60%	-2.40%	-2.30%
HJT	0.10%	-4.50%	-6.30%	-6.00%	-5.50%
Bad PERC	0.00%	-3.00%	-3.80%	-3.80%	-3.70%
Good PERC	0.00%	-1.90%	-2.30%	-2.40%	-2.30%

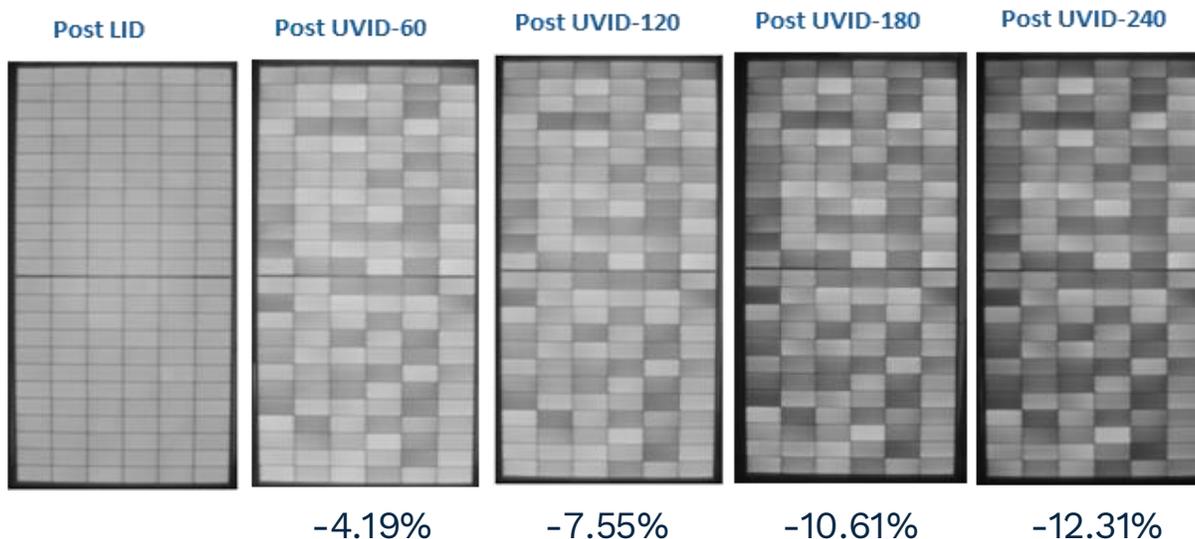
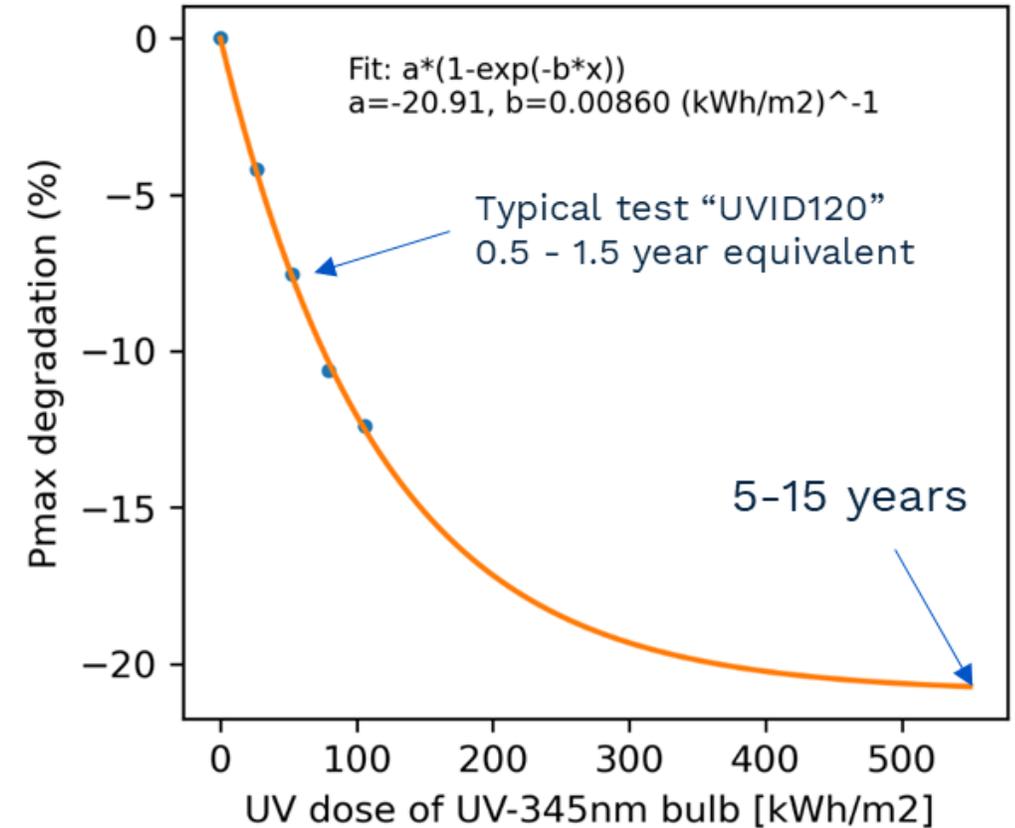
#3 – UVID – Extended UVID Testing

- Industrial TOPCon module with high UV sensitivity.
- Extrapolated using exponential fit:
 - Saturation occurs after approx. 15 years of field aging (550 kWh/m² of UV-345nm bulbs).
 - Module that loses -7.5% after “UVID120” expected to saturate at -21% power degradation.
- Kiwa PVEL will most likely introduce extended UVID testing in PQP v12 as optional.

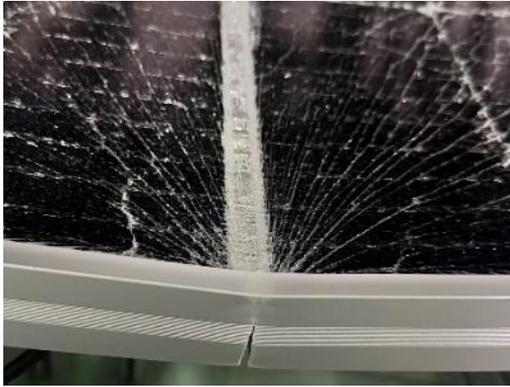
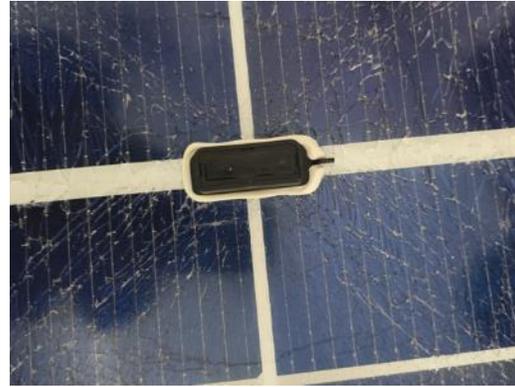
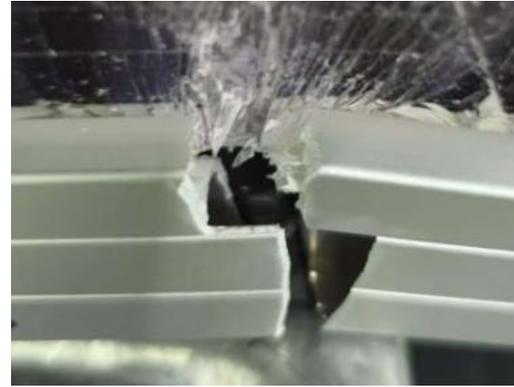
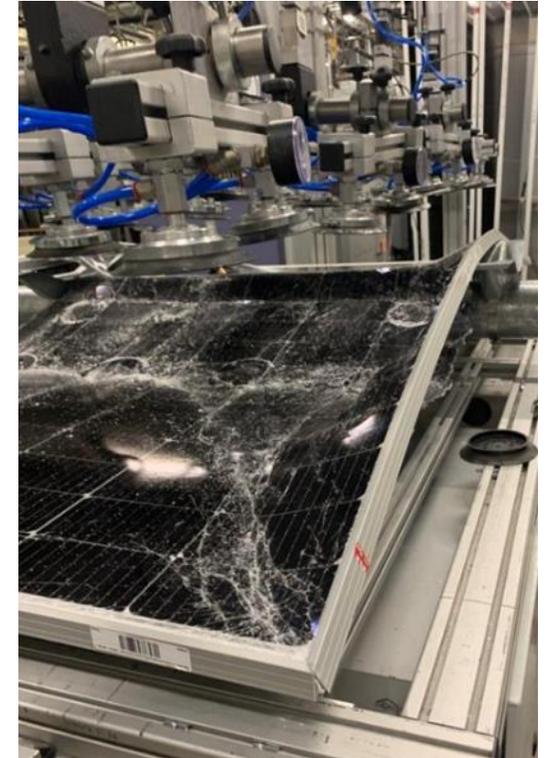
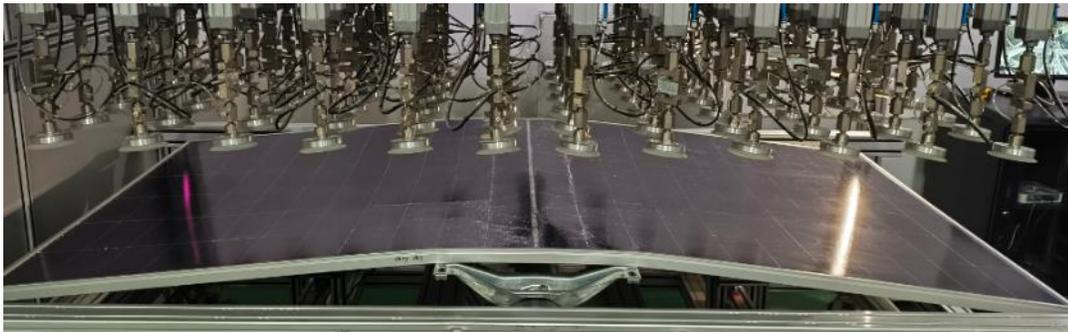
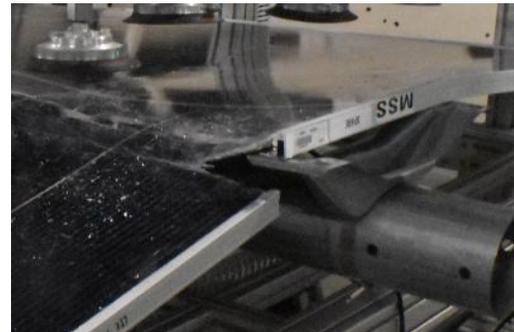
#2 – Module Breakage – No Shortage of Examples

20% of BOMs undergoing the PQP's Mechanical Stress Sequence experienced broken glass or frames. Up from just ~7% in the 2023 and 2024 Scorecards.

40% of manufacturers experienced at least one failure during MSS testing.

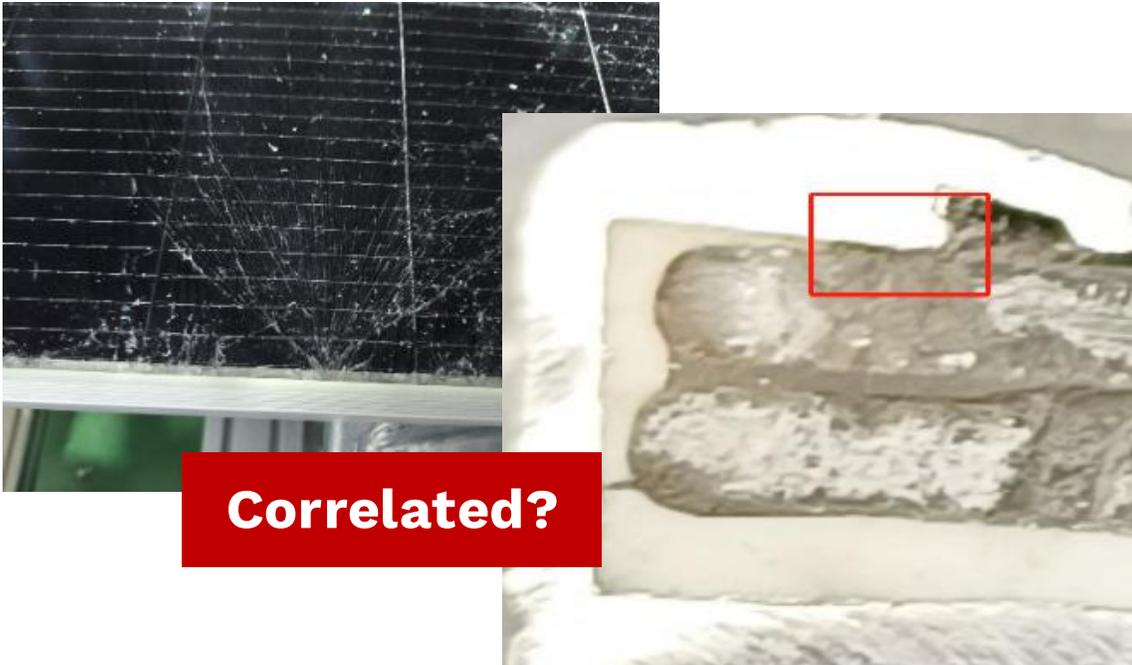
- Steep increase in SML and DML failure rates observed over the past 18 months.
- “Leading” failure mode appears to be glass breakage (front and/or rear) due to pinching.
 - Took over frame failures during 2024-2025 period

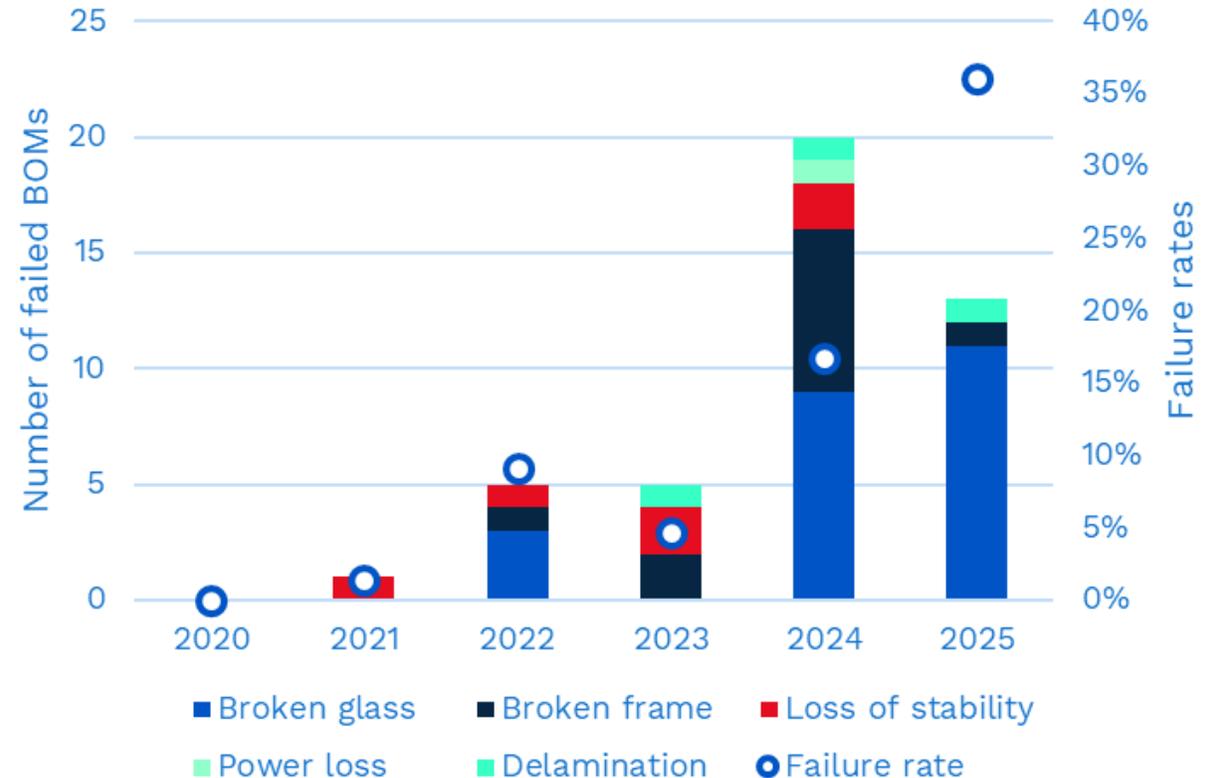
Mechanical Failures vs Production Year

Until 2023: 2400Pa, 1/4 length clamp mounting
From 2024: 1800Pa, tracker 400mm mounting

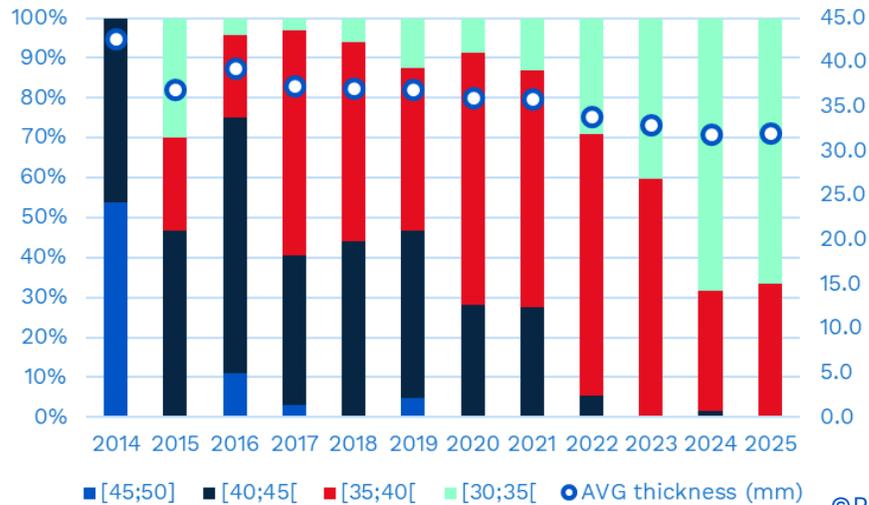
Frame Thickness (mm) vs Production Year

- Frame thickness decreasing trends:
 - Average PQP frame thickness stable 2015 to 2021
 - **Strong acceleration in reduction of frame thickness from 2022 onwards** (compounded decrease -12%)
 - Matching industry challenging situation (cost-down)
- Failure rate more than **doubled** when moving from **35mm to 30mm** frame designs.
 - Transition to stronger 6005-T6 alloy did not help

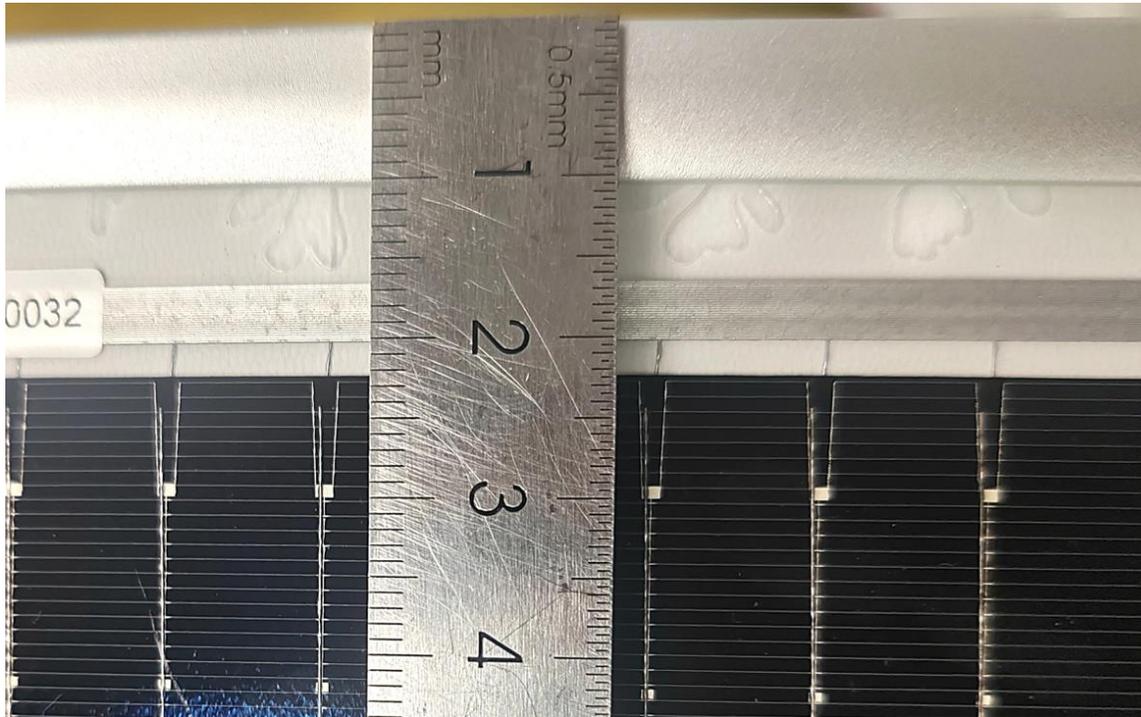
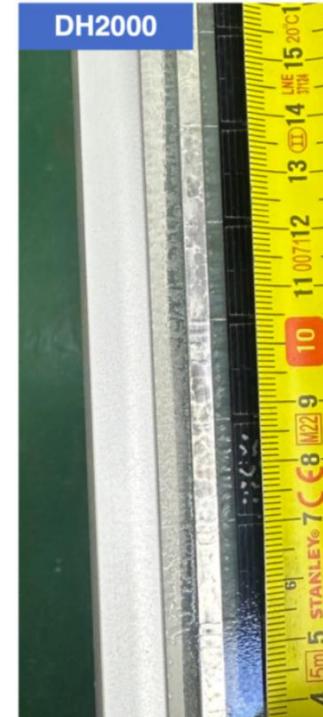
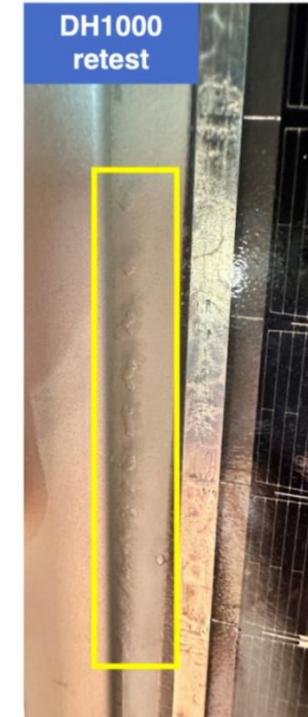
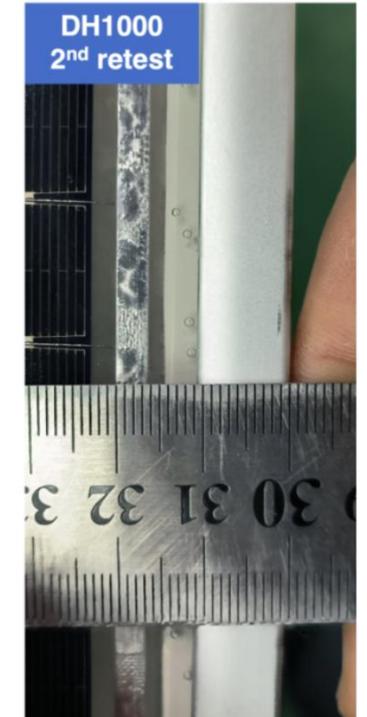
#1 – Delamination – Defects Continue to Increase

2025 Scorecard: Bubbles can be seen between the frame and the ribbon after TC600.

**For 2025 Scorecard: Affected 15% of manufacturers.
Found at pre-stress, TC200 & 600, DH1000 & 2000, TC50+HF10, PID192.**

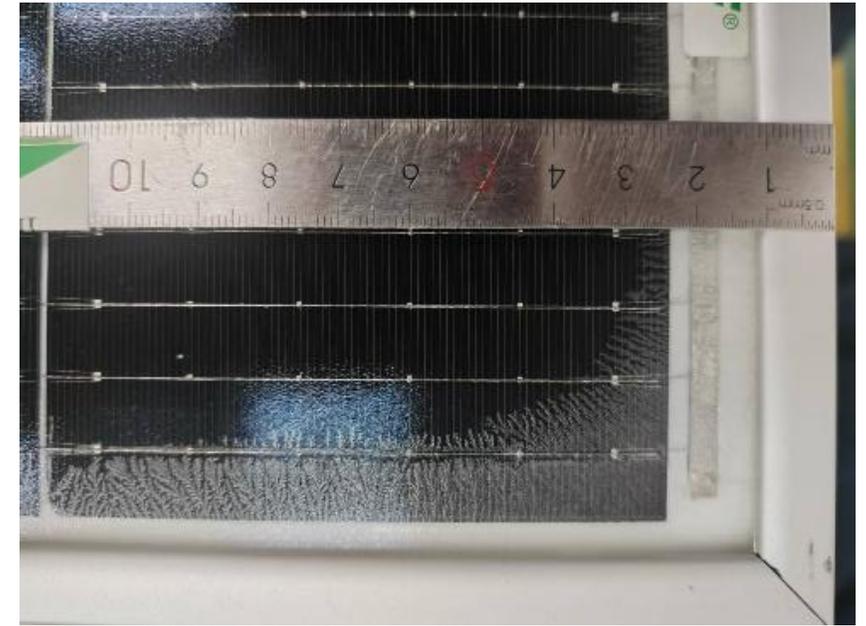
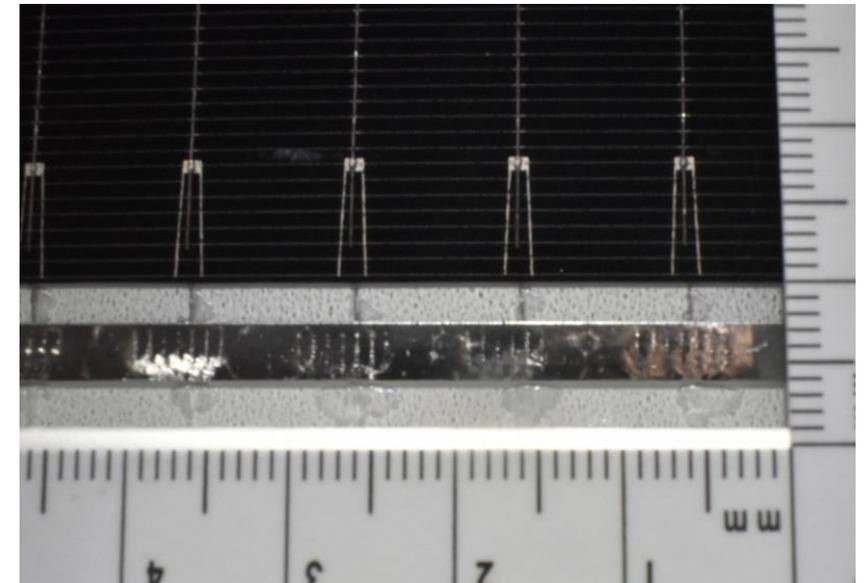
#1 – Delamination – Defects Continue to Increase

- Significant increase of encapsulant delamination occurrences over 2025.
 - 143 unique BOMs tested over the 2024-2025 period
 - 108 samples with delamination or bubble defects reported
 - ~36% (52 BOMs) with at least one occurrence
 - Included **~11% (16 BOMs) with Major defects**
 - Cluster of bubbles or delamination forming a continuous path between electrical circuit and module edge
 - Failing creepage distance requirements from IEC61730-1
 - Mostly observed post-TC, DH, MSS testing
- Possible root causes, pending further analysis:
 - Reduced encapsulant thickness and dimensions
 - Lamination process control issues (lamination time, temp.)
 - Edge pinch
 - Improper solder flux recipe and/or residue cleaning
